# The Inspection Company, LLC

## Property Inspection Report

124 Any Street, Atlanta, GA 30327  
Inspection prepared for: John Q. Client  
Real Estate Agent: George Heery - Heery Brothers

Date of Inspection: 4/16/2013 Time: 9:30 AM  
Age of Home: 51 years Size: 2,679  
Weather: 67-74°, partly cloudy

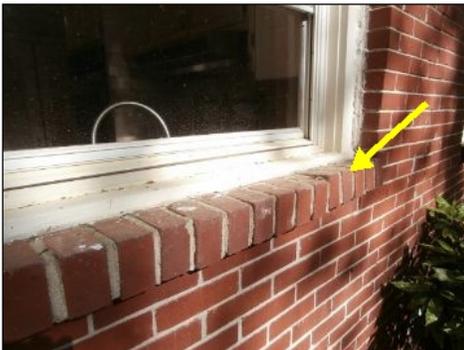
3.3. "SOLDIER COURSE" OF BRICK: The Inspector observed that the brick "soldier course" at side C (near kitchen window) is irregular as it has shifted over time. The area slopes back toward the window. There appears to be settlement of the framing and foundation at this area at a different rate than the brick. The Inspector advises the Client to arrange to have a professional contractor further evaluate and address as necessary.

twisted "soldier run" of brick

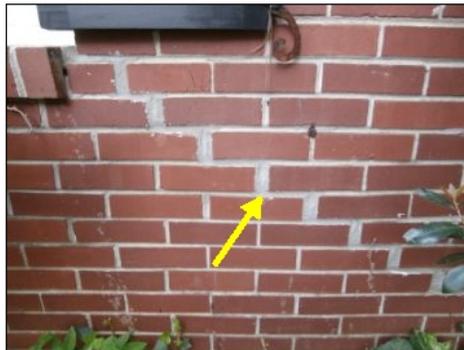
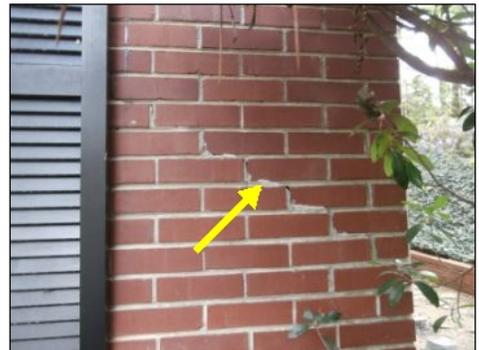
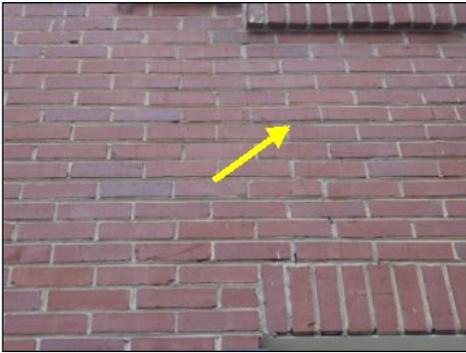
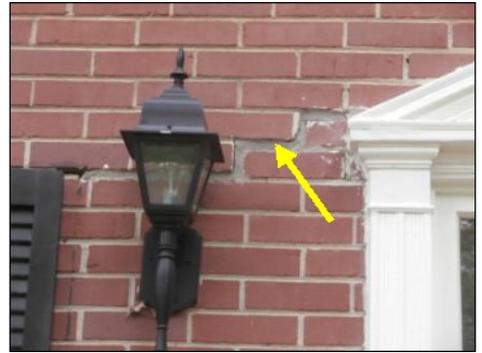
3.1. BRICK-VENEER MINOR MORTAR JOINT CRACKS: Minor, normal hairline cracks and mortar joint cracks noted a brick-veneer cladding at each side.  
 3.2. BRICK-VENEER CRACKS: The Inspector observed vertical cracking and/or "step" cracks of the brick-veneer at side(s): A. The widths are approximately 1/16" to 3/16". Most have been sealed with mortar. The cracking is typically caused by minor differential settlement. Additionally a crack is noted at side B at the second story. It is recommended to grout the cracks with mortar and monitor over time. The Inspector advises the Client to arrange to have a professional contractor further evaluate and address as necessary. The Client should consider having a structural engineer also further evaluate the concern.

previously sealed crack at side A

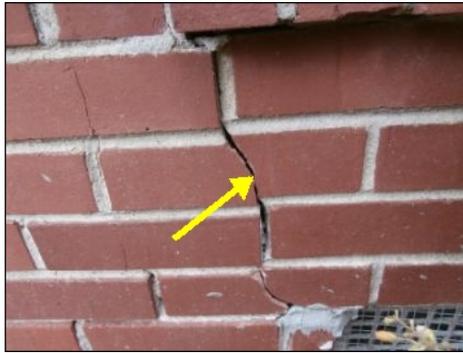
open crack at side A

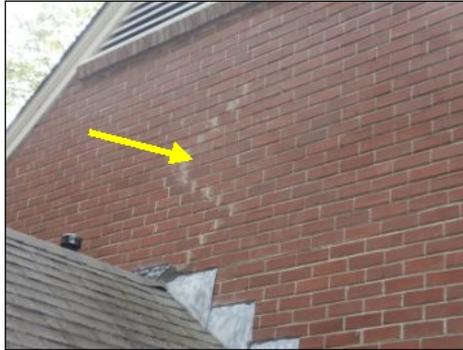
sealed crack at side B

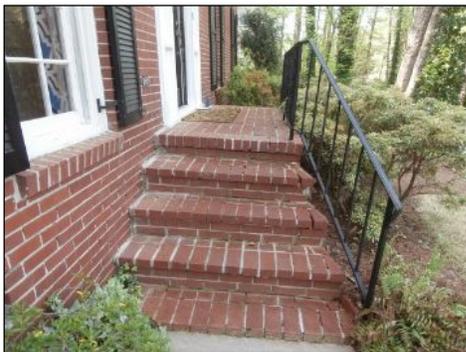
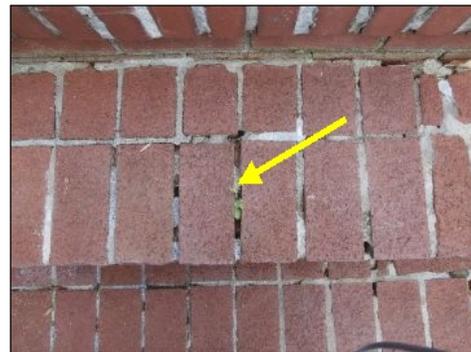
5.2. **SHIFTED MASONRY STEP STRUCTURE:** The front step structure has shifted and settled over time. The soil under the structure was likely poorly compacted at the time of initial construction. The structure appears serviceable at this time but may continue to move. It should be monitored. It may eventually have to be replaced. Re-point mortar joints as necessary too. The Inspector advises the Client to arrange to have a professional contractor further evaluate and address as necessary.

masonry step unit

missing mortar example

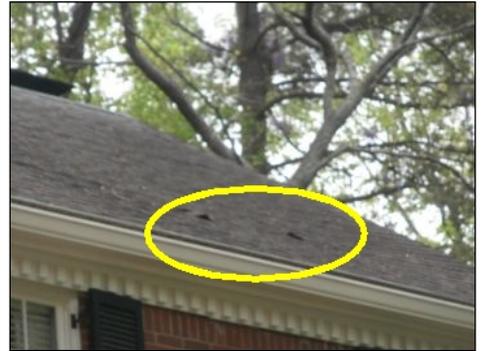
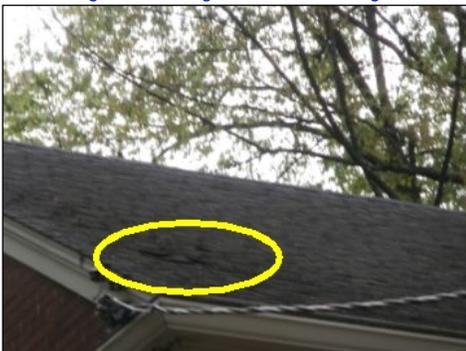
- 1.3. **NAIL POPS:** The Inspector observed some limited areas of "nail pops". This is caused by fasteners that are not set flat the the roof surface. They should be corrected. This is a minor concern that can be easily addressed. The Inspector advises the Client to arrange to have a professional certified roofing contractor further evaluate and address as necessary.

example "nail pops"

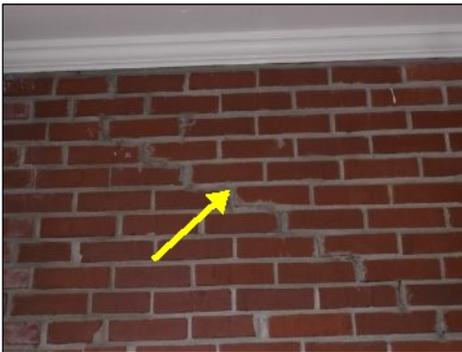
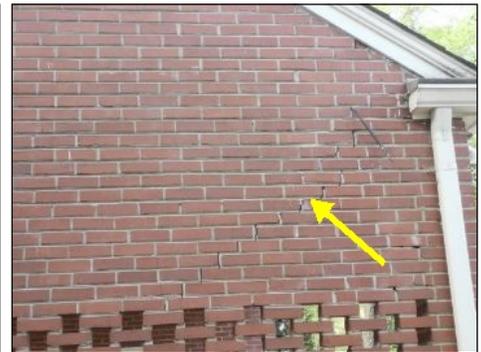
- 1.1. Appears normal.
- 1.2. Part of main dwelling (see exterior comments at previous pages).
- 1.3. BRICK-VENEER CRACKS: The Inspector observed vertical cracking and/or "step" cracks of the brick-veneer at side(s); B of the garage/carport. The width is approximately 1/16" to 1/14". The cracking is typically caused by minor differential settlement and does not appear to represent a significant structural deficit but should be checked by a structural engineer. It is recommended to grout the cracks with mortar and monitor over time. The Inspector advises the Client to arrange to have a professional contractor further evaluate and address as necessary.

*crack at side B of carport*

*step crack at side B of carport*

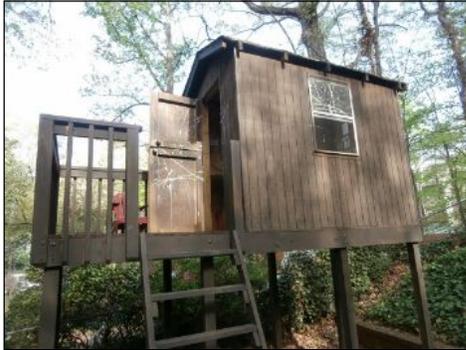
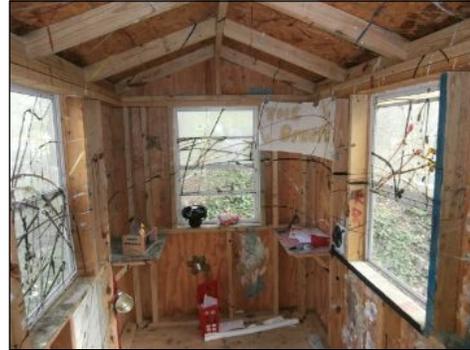
1.1. **DETERIORATED ROOF DECKING:** The Inspector observed deteriorated roof decking at the play structure. Repair as desired. Consider adding a handrail at the steps for the structure. The Inspector advises the Client to arrange to have a professional contractor further evaluate and address as necessary.

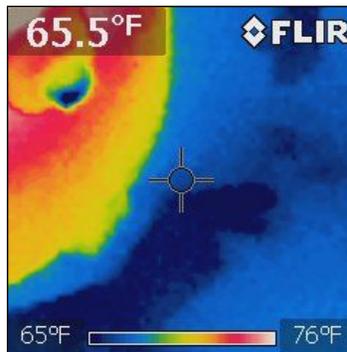
3.2. FLOOR AREA MOISTURE: The Inspector observed moisture stains at the wall bases at the following locations: utility room (water heater closet). Active moisture from a leak was confirmed as checked with a Flir infrared camera. The Inspector advises the Client to arrange to have a professional contractor further evaluate and address as necessary.

active water near water heater

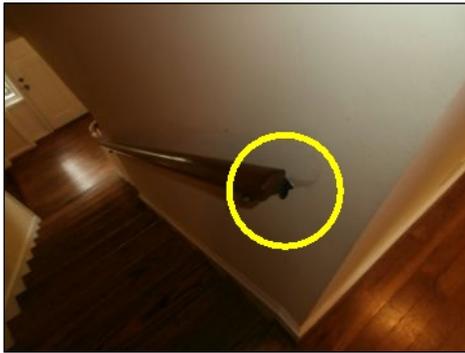
**10.1. HANRAIL RETURNS:** The Inspector observed that the handrails do not have "returns." This protects the snag hazard with open-ended handrails that can be a fall hazard. The Inspector advises the Client to arrange to have a professional contractor further evaluate and address as necessary; otherwise, use with caution.

*open ended handrail*

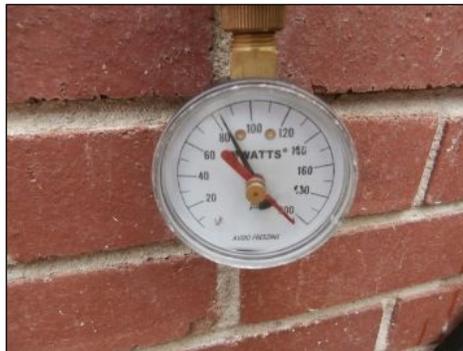
2.2. WATER PRESSURE TOO HIGH: The Inspector observed that the water pressure is too high. It should be controlled to 80 psi or less. The main valve needs adjustment or replacement. The Inspector advises that the Client arrange to have a professional licensed plumbing contractor further evaluate and address as necessary.

water pressure test

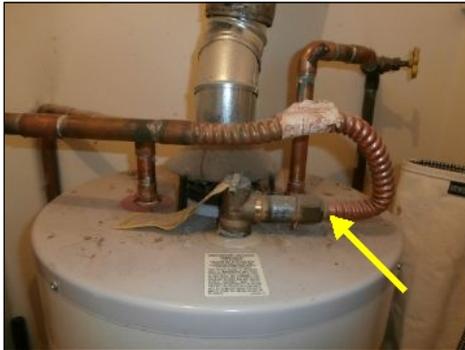
7.1. TRAPPED DISCHARGE TUBE: The Inspector observed that the water heater's safety valve discharge tube traps water. This should be corrected and the valve should be replaced due to possible corrosion. The Inspector advises the Client to arrange to have a professional plumbing contractor further evaluate and address as necessary.

*improper discharge tube installation*

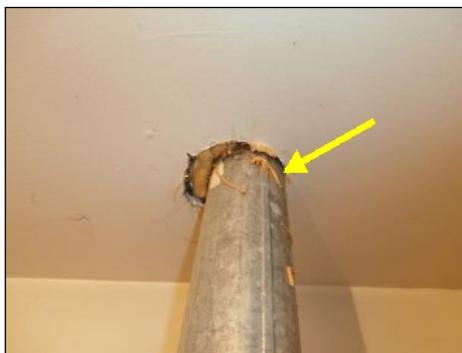
9.1. COMBUSTIBLE CLEARANCE: The Inspector observed that the vent for the water heater does not clear combustible material where it passes through the wall/ceiling. There should be a 1" gap; additionally, a thimble should be installed. This is important for fire safety. The Inspector advises that the Client arrange to have a professional licensed plumbing contractor further evaluate and address as necessary.

*deficient clearance from combustible material*

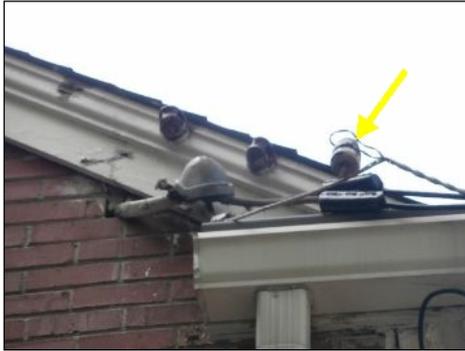
1.1. **DETACHED SERVICE DROP ANCHOR:** The Inspector observed that the service drop anchor is detached at the side of the house. This could be a hazard and should be repaired immediately. The Inspector advises the Client to arrange to have a professional, licensed electrician further evaluate and address as necessary for safety.

*detached anchor*

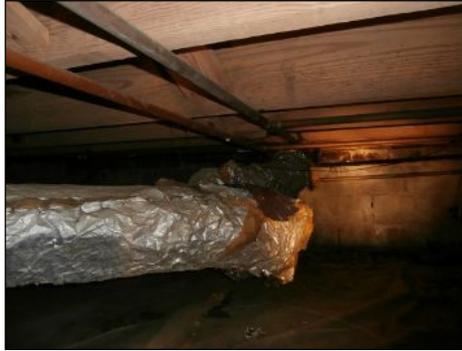
3.2. DAMAGED/POORLY INSTALLED SUPPLY DUCT: The Inspector observed a damaged duct at underfloor-crawl space at side B. Leaking ducts raise energy bills. The Inspector advises the Client to arrange to have a professional, NATE certified HVAC contractor further evaluate and address as necessary.

poor ductwork

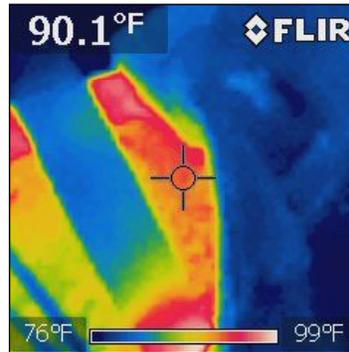
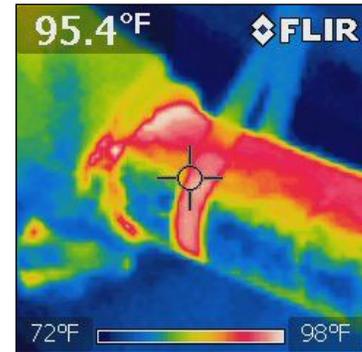
Observations:  
**2.1. CLEANING & SERVICING OF DUCTWORK:** The ductwork is recommended to be cleaned and serviced. Insulating jackets need minor general repairs. The duct joints should be sealed with mastic. Servicing should help prevent wasted energy by reducing loss of conditioned air. The Inspector advises the Client to arrange to have a professional, NATE certified HVAC contractor further evaluate and address as necessary.

minor duct leakage

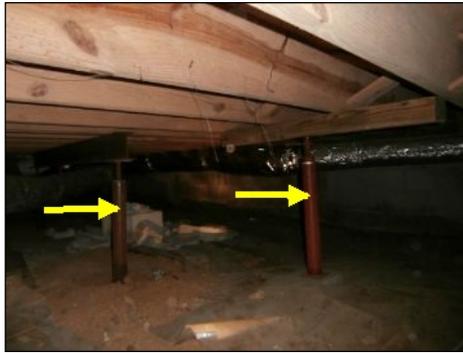
5.2. AUXILIARY JACK POSTS: The Inspector observed approximately three screw-type jack posts installed to provide auxiliary floor support structure at the crawl space. These are not critical supports and appear to be intended to address deflection of the common joists of this section of the floor system. These posts, however, are not founded on footers, and the posts are not rated for permanent use. Correction is recommended with installation of poured-in-place concrete footers set 12" deep. 6x6" preservative-treated posts can then set on top of the footers to support a three-ply 2x6" beam or laminated beam. The Inspector advises the Client to arrange to have a professional contractor further evaluate and address as necessary.

auxiliary floor posts
