The Inspection Company, LLC

Property Inspection Report

123 Atlanta Ave., Atlanta, GA 30316
Inspection prepared for: John Q. Client
Real Estate Agent: Jane A. Agent - ABC Realty Company

Date of Inspection: 12/10/2014 Time: 9:00 AM
Age of Home: 1930 | Size: 1400 SF
Weather: 51°, sunny

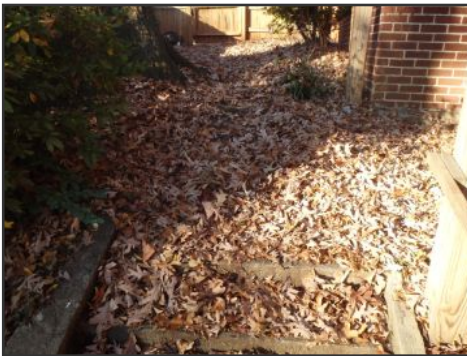
2.3. GRIPPABLE HANDRAIL--STEPS AT WALKWAY: The Inspector did not observe a handrail at the exterior steps at side A near the walkway that leads to street or at side D at brick steps to back yard. The brick steps at side D are also uneven and irregular; this increases risk hazard--consider repair there too. Handrails are very important for mitigating falls on steps, a leading cause of home-related injuries. Installation of handrails is always highly recommended where four risers or more are present. The Inspector advises the Client to arrange to have a professional contractor further evaluate and address as necessary.

walkway and steps at side D

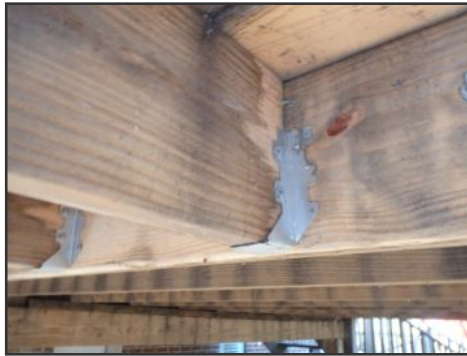
3.6. JOIST HANGERS--IMPROPER INSTALLATION WITH SCREWS: The Inspector observed some joist hangers at deck on the right side section. The joist hangers should be installed with 12D nails to prevent joist failure. Screws do not have proper shear ratings; only framing nails rated for use with preservatively-treated wood should be used. Additionally, the hangers are undersized. The Inspector advises the Client to arrange to have a professional contractor further evaluate and address as necessary.

joist hangers undersized and improperly connected with screws

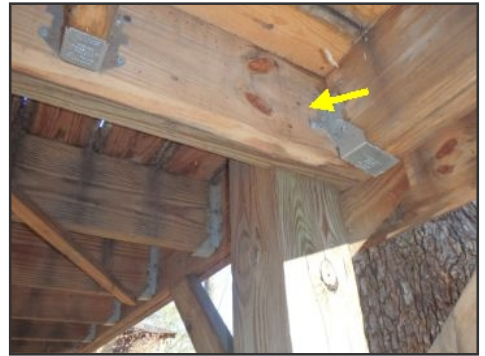
beam/ledger not bolted to post--example

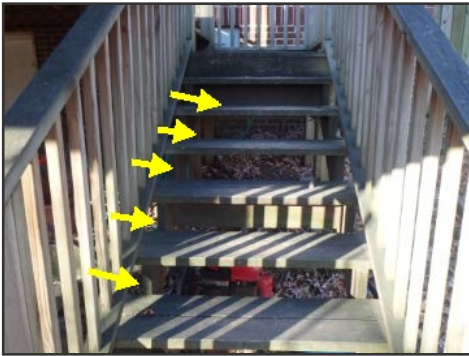
open risers can be hazard for children

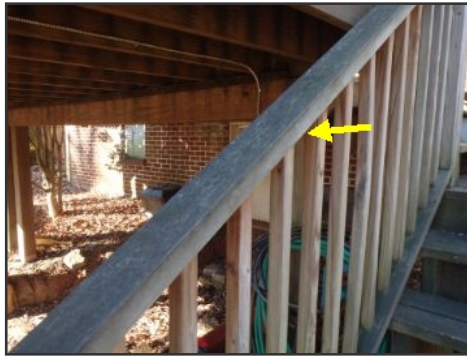
Page 14 Item: 4	Deck Stairs	<p>4.1. GRIPPABLE HANDRAIL MISSING: The Inspector did not observe a grippable handrail at the deck stairs. Handrails help prevent falls and injuries on steps and stairs. The installation of a properly sized handrail is advised. Generally, handrails should be no more than 2.25" and have a proper profile and projection. This is an important but easily correctable concern. The Inspector advises the Client to arrange to have a professional contractor further evaluate and address as necessary.</p> <p>4.2. LANDING: There is no landing at the the bottom of the deck steps. Current building standards require landings at doors where steps have three or more risers. The steps should be used with caution unless upgraded. Note that this also creates wood to earth contact, and the bottom of the step stringers may prematurely deteriorate. The Inspector advises the Client to arrange to have a professional contractor further evaluate and address as necessary.</p> <p>4.3. RISER BOARDS: The Inspector did not observe riser boards at the steps. Riser boards are required to help prevent a small child from slipping through the openings of the steps. Correction is recommended for safety of small children. The Inspector advises the Client to arrange to have a professional contractor further evaluate and address as necessary.</p> <p>4.4. STAIR STRINGER BRACKETS: The Inspector did not observe that the stair stringers are connected to the side of the deck with brackets. Current standards required sloped joist hanger brackets with 625 lb rating be installed to connect stringers and prevent detachment. The Inspector advises the Client to arrange to have a professional contractor further evaluate and address as necessary.</p>

missing grippable handrail

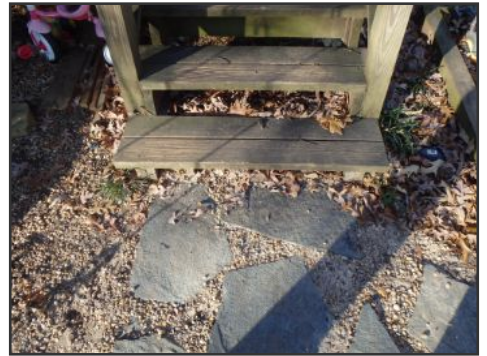
missing concrete landing

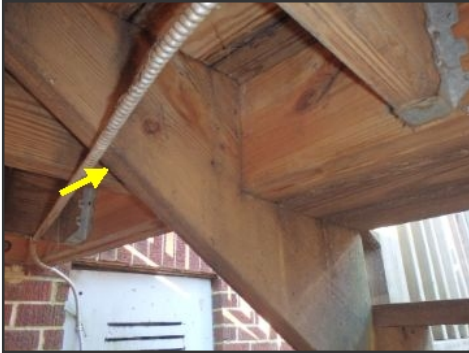
- 4.4. STAIR STRINGER BRACKETS: The Inspector did not observe that the stair stringers are connected to the side of the deck with brackets. Current standards required sloped joist hanger brackets with 625 lb rating be installed to connect stringers and prevent detachment. The Inspector advises the Client to arrange to have a professional contractor further evaluate and address as necessary.

deficient attachment of stair stringers

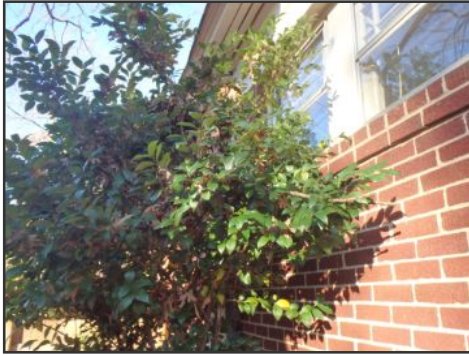
Observations:
6.1. TREE LIMBS NEED MAINTENANCE: There are tree limbs that are growing too close to the home and can cause moisture damage to the cladding and trim. The trees should be maintained to within 6 feet of the exterior of the building. This is easily correctable. The Inspector advises the Client to arrange to have a professional landscape contractor further evaluate and address as necessary.
6.2. VEGETATION NEEDS MAINTENANCE: The shrubs, bushes, and vines are growing too close to the home and can cause moisture damage to the cladding and trim. The vegetation should be maintained to within 24" of the exterior of the building. The Inspector advises the Client to arrange to have a professional landscape contractor further evaluate and address as necessary.

example overgrown bush

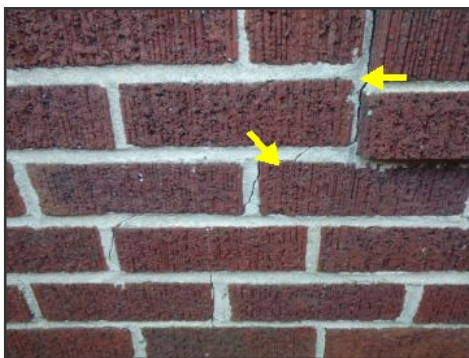
hairline crack at side B

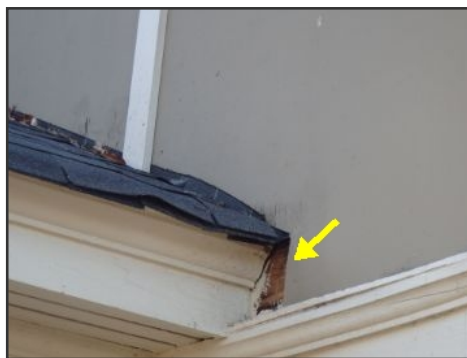
3.4. WOOD TRIM DETERIORATION--MINOR: The Inspector observed some minor areas of wood trim deterioration at side A where the porch roof meets the wall. The damaged areas of trim should be replaced in-kind. The trim prevents water damage to the wall structure. Also, install kickout flashing to protect the trim from water damage in future. The Inspector advises the Client to arrange to have a professional contractor further evaluate and address as necessary.

minor wood damage and missing flashing/trim

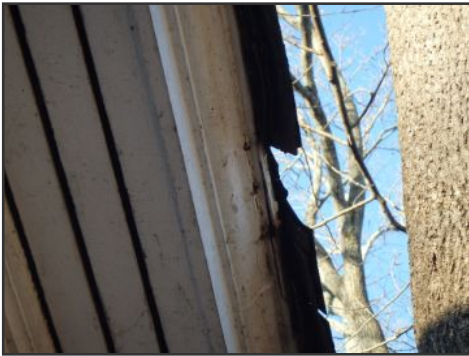
slight damage to eaves at side B

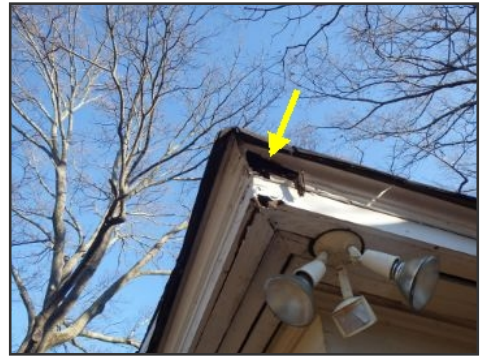
wood deterioration at side A

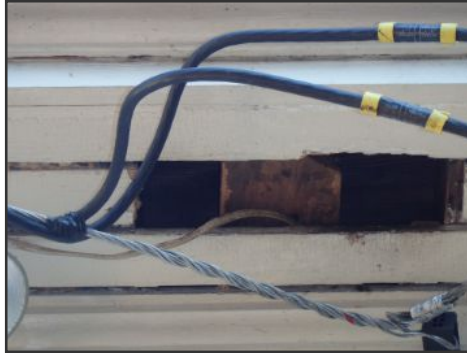
Page 18 Item: 7	Eaves & Facia	<p>7.2. SOFFIT BOARD--DETACHED: The Inspector observed soffit board detachment at side(s): D. The damaged panels should be replaced/repared to prevent pest entry to the attic. The Inspector advises the Client to arrange to have a professional contractor further evaluate and address as necessary.</p> <p>7.3. EAVE DETERIORATION--LIMITED: The Inspector observed some limited areas of eave deterioration at side A (front right corners) and small area at side B (see images). The damaged areas of eaves should be replaced in-kind. The eaves prevent water damage to the wall structure. The Inspector advises the Client to arrange to have a professional contractor further evaluate and address as necessary.</p>

7.1. Appears normal.
7.2. SOFFIT BOARD--DETACHED: The Inspector observed soffit board detachment at side(s): D. The damaged panels should be replaced/repared to prevent pest entry to the attic. The Inspector advises the Client to arrange to have a professional contractor further evaluate and address as necessary.
7.3. EAVE DETERIORATION--LIMITED: The Inspector observed some limited areas of eave deterioration at side A (front right corners) and small area at side B (see images). The damaged areas of eaves should be replaced in-kind. The eaves prevent water damage to the wall structure. The Inspector advises the Client to arrange to have a professional contractor further evaluate and address as necessary.

open soffit at side D

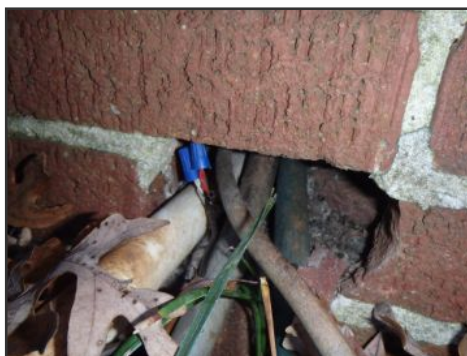
Observations:
9.1. Appears normal.
9.2. GAPS AT FOUNDATION WALL AT PIPES: The Inspector observed openings around pipe penetration at side C of the home. The gaps should be sealed with mortar to prevent rodent entry into the crawl space. The Inspector advises the Client to arrange to have a professional contractor further evaluate and address as necessary.

gap could allow rodent entry--side C

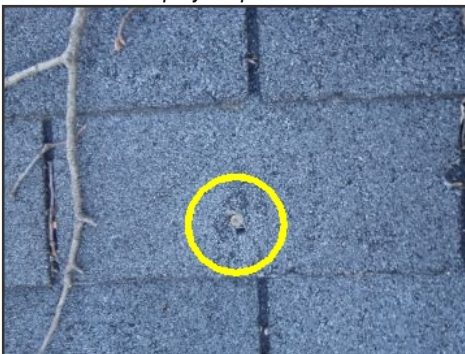
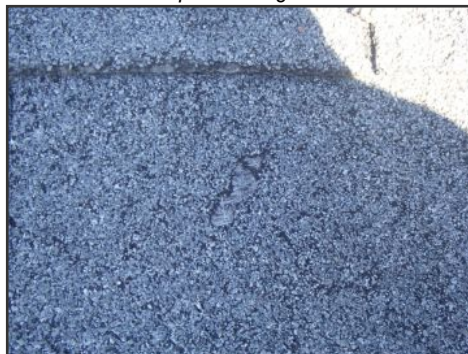
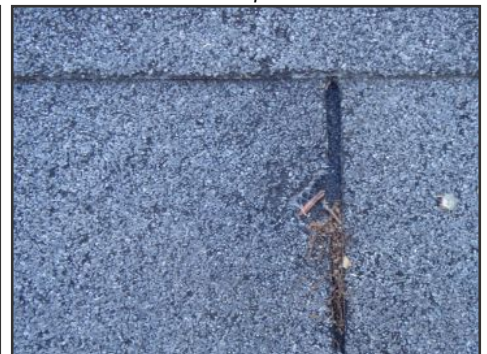
1.2. **GENERAL MINOR DAMAGE AT ROOF COVERING:** The Inspector observed some areas of asphalt shingles with tears, abrasions, nail holes, etc. The damaged shingles should be repaired to prevent possible roof leaks. The Inspector advises the Client to arrange to have a professional roofing contractor further evaluate and address as necessary.

example damaged area

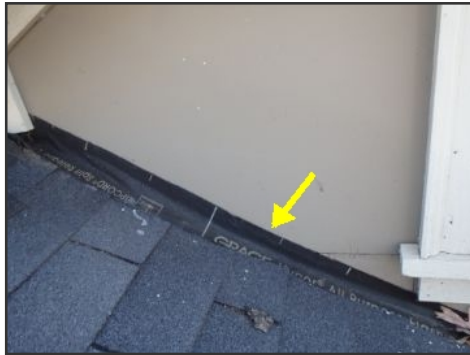
2.1. Appears normal. Note the visibility of flashing is very limited.
 2.2. VERTICAL WALL FLASHING--IMPROPER: The Inspector observed that the vertical wall flashing is improper at side A. Roof-to-wall flashing should be step flashing. Repairs should be made to prevent leaks. The Inspector advises the Client to arrange to have a professional certified roofing contractor further evaluate and address as necessary.

improper vertical wall flashing

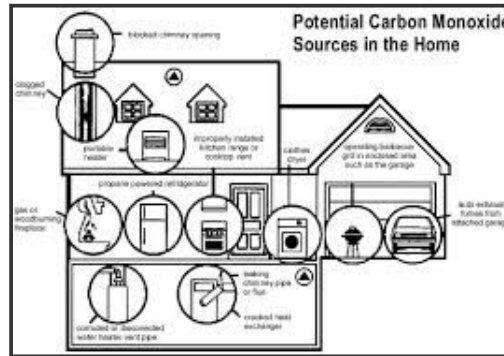
Page 24 Item: 2	Carbon Monoxide Detectors	2.1. CARBON MONOXIDE DETECTORS NEEDED: Carbon monoxide (CO), an odorless, colorless gas, which can cause sudden illness and death, is produced any time a fossil fuel is burned. CPSC recommends that one CO alarm be installed in the hallway outside the bedrooms in each separate sleeping area of the home. CO alarms may be installed into a plug-in receptacle or high on the wall. Hard wired or plug-in CO alarms should have battery backup. The Inspector strongly advises the home be equipped with carbon monoxide detectors.
Bathroom--Private		
Page 27 Item: 5	Venting	5.1. NOISY BATHROOM VENT FAN: The Inspector observed that the vent fan is very noisy. The motor may be beginning to fail from age. The Inspector advises the Client to arrange to have a professional contractor further evaluate and address as necessary.

2.1. CARBON MONOXIDE DETECTORS NEEDED: Carbon monoxide (CO), an odorless, colorless gas, which can cause sudden illness and death, is produced any time a fossil fuel is burned. CPSC recommends that one CO alarm be installed in the hallway outside the bedrooms in each separate sleeping area of the home. CO alarms may be installed into a plug-in receptacle or high on the wall. Hard wired or plug-in CO alarms should have battery backup. The Inspector strongly advises the home be equipped with carbon monoxide detectors.

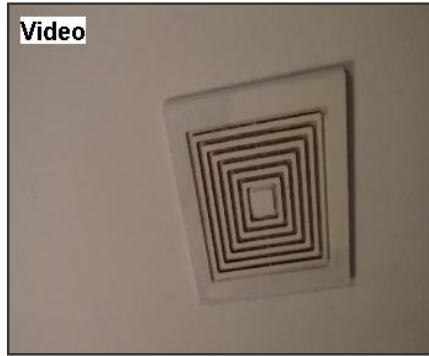
- 5.1. NOISY BATHROOM VENT FAN: The Inspector observed that the vent fan is very noisy. The motor may be beginning to fail from age. The Inspector advises the Client to arrange to have a professional contractor further evaluate and address as necessary.

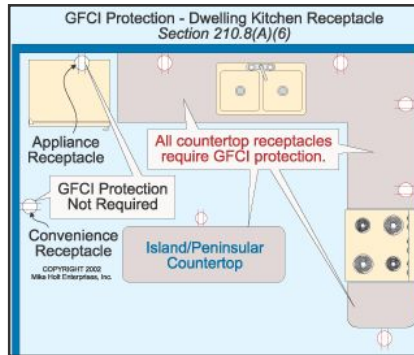
- 8.1. Appears normal at one unit near sink. **GFCI** present and functioning. They should be tested often as they have a short lifespan.
- 8.2. **LACKING COUNTER RECEPTACLES:** The Inspector observed that the kitchen countertop is not adequately served with receptacles per current standards. At least 3 more are recommended, particularly at side C. A receptacle should be available to serve each 2' section of a counter. The Inspector advises the Client to arrange to have a professional, licensed electrician further evaluate and address as necessary for safety.
- 8.3. **REVERSE POLARITY:** The Inspector observed reverse polarity (hot/neutral reverse wiring) at the far left receptacle at side B of the kitchen. The Inspector advises the Client to arrange to have a professional, licensed electrician further evaluate and address as necessary for safety.

receptacle placement

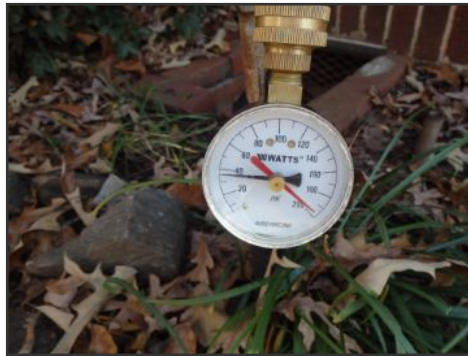
2.1. **WATER PRESSURE TOO LOW:** The Inspector tested with water pressure with a gauge and found it to be 35 psi. The cause is estimated to be from rusted galvanized pipes. Additionally, a pressure control valve is needed. See video of flow example at bathroom. The Inspector advises the Client to arrange to have a professional, licensed plumber further evaluate and address as necessary.

water pressure test

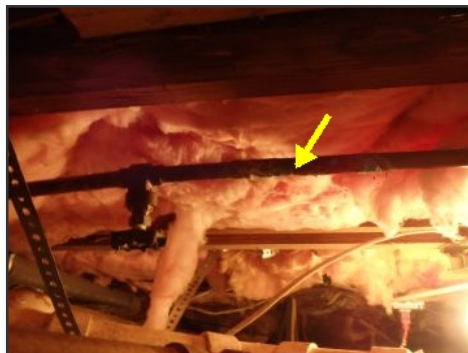
Page 32 Item: 3	Water Supply Piping	3.2. LEAKING WATER SUPPLY PIPE--MINOR: The Inspector observed a leak at a water supply pipe at the underfloor area under the main bathroom--hallway. The leak should be repaired. The Inspector advises the Client to arrange to have a professional, licensed plumber further evaluate and address as necessary. 3.3. GALVANIZED PIPE--MAIN--AGED: The Inspector observed that the home's main water line is galvanized material. While no leaks were observed at the time of inspection, the pipe is aged. It may fail soon due to age and condition. Water pressure is already low--estimated cause is rust inside pipe. The pipe deteriorates from the inside out. The Inspector advises the Client to arrange to have a professional, licensed plumber further evaluate and address as necessary. 3.4. GALVANIZED PIPE--DETERIORATED: The Inspector observed that the home has some branch galvanized water supply pipe. While no leaks were observed at the time of inspection, the pipe is heavily rusted and deteriorated. It may fail soon due to age and condition. The Inspector advises the Client to arrange to have a professional, licensed plumber further evaluate and address as necessary.

leak at pipe under bathroom

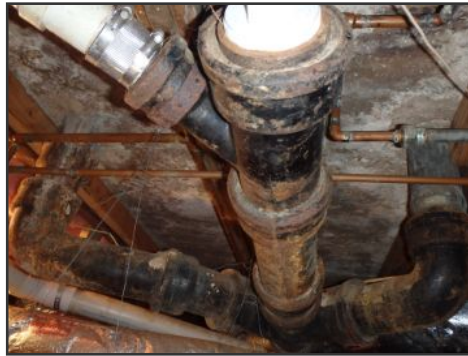
Page 32 Item: 4	Drain/Waste/Vent Piping	4.1. CAST IRON PIPE--AGED: The home still has some cast iron drain/waste/vent pipes in use. While the system still appears to be serviceable, there may be concealed deterioration inside the pipe and underground. The Inspector cannot predict the remaining useful lifespan of the pipes. The pipes should be monitored in the meantime. HUD (US Dept. of Housing and Urban Development) estimates cast iron pipes last 50 years on average.

4.1. CAST IRON PIPE--AGED: The home still has some cast iron drain/waste/vent pipes in use. While the system still appears to be serviceable, there may be concealed deterioration inside the pipe and underground. The Inspector cannot predict the remaining useful lifespan of the pipes. The pipes should be monitored in the meantime. HUD (US Dept. of Housing and Urban Development) estimates cast iron pipes last 50 years on average.

general image of cast iron drain pipes

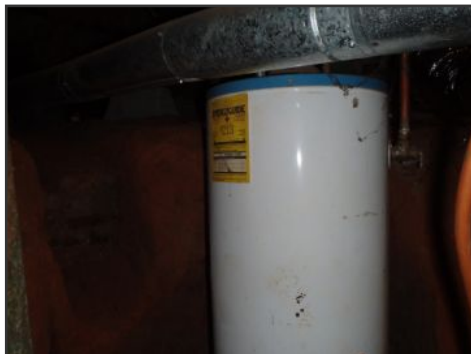
Page 33 Item: 5	Water Heater	<p>5.3. AGED GAS WATER HEATER--SAFETY CONCERN: The Inspector observed a gas-fired water heater that was manufactured prior to 2003. Water heaters manufactured before July 1st, 2003, are highly recommended to be replaced due to safety concerns with the exposed combustion chamber. Older units cause around 800 residential fires resulting in an average of 5 deaths and 130 injuries annually. Newer units prevent flammable vapor ignition in the area of the water heater through the implementation of what is referred to as a "flame arrestor", whereby flashback fires are prevented by burning the gas vapors inside of the heater while greatly reducing the risk of igniting flammable gases nearby. Although the water heater operated properly at the time of inspection, it is advised to replace it due to safety concern. The Inspector advises the Client to arrange to have a professional, licensed plumber further evaluate and address as necessary.</p> <p>5.4. EXCEEDED LIFESPAN: Though it operated at the time of inspection, it is noted that the water heater is well beyond the end of its useful lifespan and should be monitored for replacement. It is 25 years old. HUD estimates typical lifespans to be 10-11 years for tank water heaters. The Inspector advises the Client to arrange to have a professional, licensed plumber further evaluate and address as necessary.</p>

5.4. **EXCEEDED LIFESPAN:** *Though it operated at the time of inspection, it is noted that the water heater is well beyond the end of its useful lifespan and should be monitored for replacement. It is 25 years old. HUD estimates typical lifespans to be 10-11 years for tank water heaters. The Inspector advises the Client to arrange to have a professional, licensed plumber further evaluate and address as necessary.*

Mor-Flor brand water heater

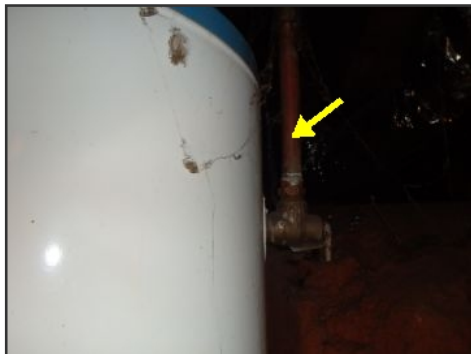
Page 34 Item: 7	Safety Relief Valve	<p>7.1. DISCHARGE TUBE--IMPROPERLY TRAPS WATER: The Inspector observed that the water heater's IPR valve discharge tube improperly traps water with no bleed valve. This could be a hazard as trapped water can cause corrosion and valve failure. The Inspector advises the Client to arrange to have a professional plumbing contractor further evaluate and address as necessary.</p>
Page 35 Item: 11	Washer/Dryer Connections	<p>11.2. DEFICIENT DRYER DUCT: The dryer duct is improper flexible material. Only smooth, rigid dryer ducts should be installed at underfloor/attic areas. Dryer ducts should be 35' or less (reduce allowable length by 5' for every 90° elbow). It is recommended to change the duct to the correct material to reduce fire hazard. The Inspector advises the Client to arrange to have a professional contractor further evaluate and address as necessary.</p>

7.1. **DISCHARGE TUBE--IMPROPERLY TRAPS WATER:** The Inspector observed that the water heater's **TPR valve** discharge tube improperly traps water with no bleed valve. This could be a hazard as trapped water can cause corrosion and valve failure. The Inspector advises the Client to arrange to have a professional plumbing contractor further evaluate and address as necessary.

TPR valve discharge tube is improperly installed

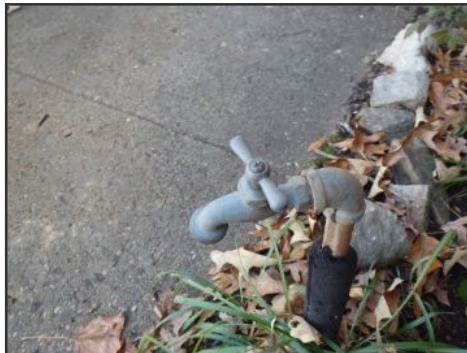
10.2. The hose bibs need backflow prevention adaptors. This is an easy correction that can prevent water contamination.

water hose faucet at side A

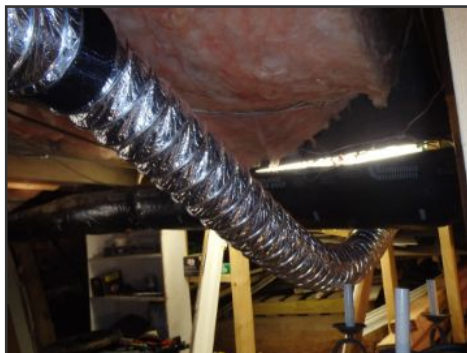
11.2. DEFICIENT DRYER DUCT: The dryer duct is improper flexible material. Only smooth, rigid dryer ducts should be installed at underfloor/attic areas. Dryer ducts should be 35' or less (reduce allowable length by 5' for every 90° elbow). It is recommended to change the duct to the correct material to reduce fire hazard. The Inspector advises the Client to arrange to have a professional contractor further evaluate and address as necessary.

improper dryer duct material

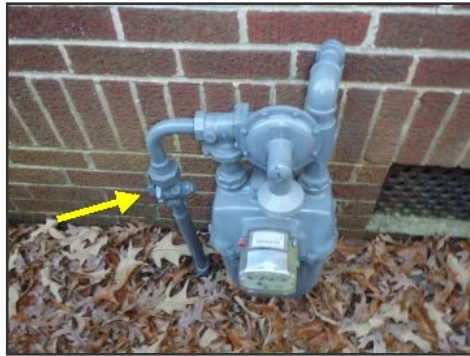
12.2. MAIN GAS VALVE: The home has a main gas valve on the utility providers side of the meter; however, there is no main gas valve on the homeowner's side of the gas meter. This is very common for older homes. Newly adopted fuel gas standards require two main gas shutoff valves. Sometimes gas supply companies require the secondary valve to be installed during a change of ownership or lapse in service. This is not always required. The Inspector advises that the Client arrange to have a professional licensed plumbing contractor further evaluate and address as necessary.

main gas valve

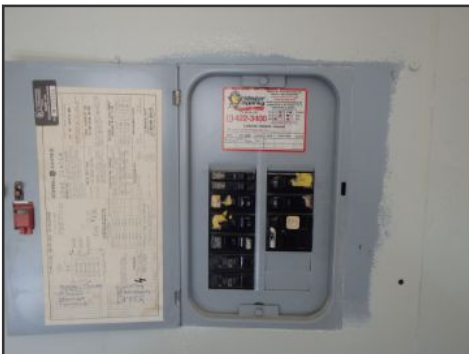
Electrical		
Page 38 Item: 5	Distribution Panelboard A	<p>5.2. OVERFUSED CIRCUITS--BEDROOM PANELBOARD: The Inspector observed two 14 gauge rated circuits that were improperly connected to 20 Amp breakers. They should be connected to 15 Amp breakers. The Inspector advises the Client to arrange to have a professional, licensed electrician further evaluate and address as necessary for safety.</p>
Page 39 Item: 6	Distribution Panelboard B	<p>6.2. OVERFUSED CIRCUITS--KITCHEN PANELBOARD: The Inspector observed two 14 gauge rated circuits that were improperly connected to 20 Amp breakers. They should be connected to 15 Amp breakers. The Inspector advises the Client to arrange to have a professional, licensed electrician further evaluate and address as necessary for safety.</p>

5.2. OVERFUSED CIRCUITS--BEDROOM PANELBOARD: The Inspector observed two 14 gauge rated circuits that were improperly connected to 20 Amp breakers. They should be connected to 15 Amp breakers. The Inspector advises the Client to arrange to have a professional, licensed electrician further evaluate and address as necessary for safety.

panelboard on right--GE brand

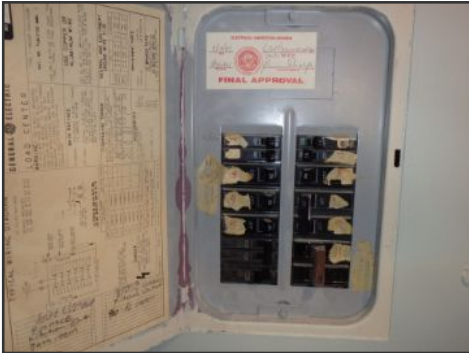
6.2. OVERFUSED CIRCUITS--KITCHEN PANELBOARD: The Inspector observed two 14 gauge rated circuits that were improperly connected to 20 Amp breakers. They should be connected to 15 Amp breakers. The Inspector advises the Client to arrange to have a professional, licensed electrician further evaluate and address as necessary for safety.

panelboard on left--GE brand

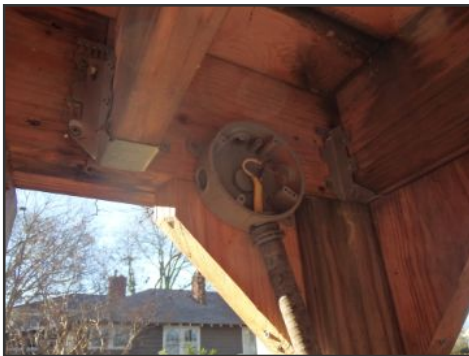
abandoned circuits should be removed

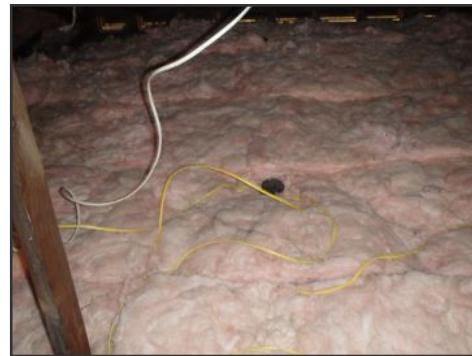
Page 40 Item: 8	Branch Circuits	<p>8.2. ROMEX STAPLES--ATTIC: The Inspector observed some circuits in the attic that need to be secured with romex staples. Securing the circuits helps prevent detachment and a hazard. The Inspector advises the Client to arrange to have a professional, licensed electrician further evaluate and address as necessary.</p> <p>8.3. ABANDONED CIRCUITS: Abandoned circuits were observed at the exterior at side C. All old, unused circuits should be removed. The Inspector advises the Client to arrange to have a professional, licensed electrician further evaluate and address as necessary for safety.</p> <p>8.4. RODENT DAMAGE--ELECTRICAL CIRCUITS--ATTIC: The Inspector observed electrical circuits that have rodent damage. See example image. The damaged areas should be replaced. Example of circuits under insulation should be conducted by electrician too. The Inspector advises the Client to arrange to have a professional, licensed electrician further evaluate and address as necessary for safety.</p>

loose circuits--example

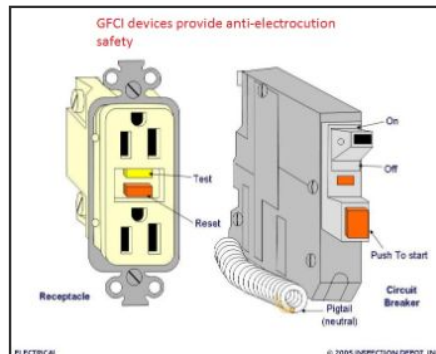
- 12.1. EXTERIOR GFCI: The exterior receptacle is not GFCI compliant. The GFCI device is defective. GFCI technology is required by the National Electrical Code to protect occupants against electrical shock and injury at "wet locations." GFCI protection may not be present in some older homes, but it is suggested as an upgrade. The Inspector advises the Client to arrange to have a professional, licensed electrician further evaluate and address as necessary for safety.

GFCI devices

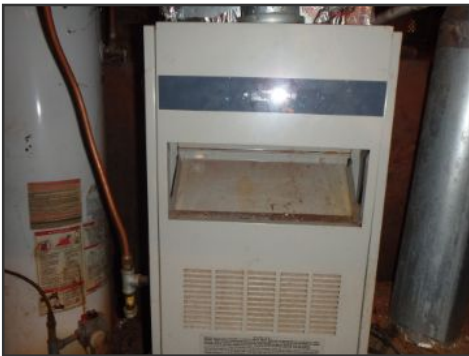
- 1.1. Appears normal. Heating system was operated during the inspection.
- 1.2. EXCEEDED LIFESPAN--GAS FURNACE: The furnace is aged at 25 years. Aged furnaces can sometimes have hidden heat exchanger cracks that can be a carbon monoxide hazard. While it functioned at the time of inspection, it has exceeded its statistical life expectancy. HUD estimates typical lifespans to be 15-17 years for gas furnaces. The Client is advised to anticipate replacement in the immediate future. The Inspector advises the Client to arrange to have a professional, NATE certified HVAC contractor further evaluate and address as necessary.

ICP brand furnace--100,000 BTU--25 yrs old

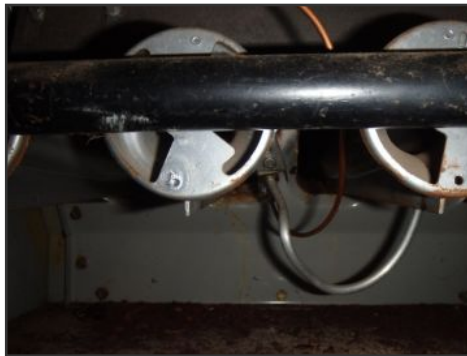
rusted condition of heat exchanger

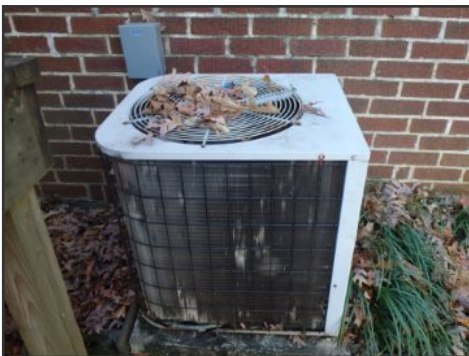
Page 44 Item: 4	Central Air Conditioning	<p>4.2. EXCEEDED LIFESPAN--CONDENSER: The air conditioner is aged at 25 years. It has exceeded its statistical life expectancy and should be monitored for replacement. Typical lifespan of an air conditioning unit is 10-15 years. The Client is advised to anticipate replacement in the immediate future. The Inspector advises the Client to arrange to have a professional, NATE certified HVAC contractor further evaluate and address as necessary.</p> <p>4.3. OVERFUSED: The 40 Amp breaker for the air conditioning unit is too large as per the manufacturer's rating of 30 Amps. It should be changed as an oversized breaker could cause damage to the unit and could void the warranty. The Inspector advises the Client to arrange to have a professional, licensed electrician change the breaker.</p>
Page 44 Item: 6	Servicing of HVAC	<p>6.1. HVAC--RECOMMEND SERVICING: The Inspector did not observe any evidence that the HVAC has been serviced in the past twelve months. The Inspector highly recommends that professional and thorough servicing of the system be performed by a licensed, NATE Certified HVAC contractor.</p>

- 4.1. Appears normal. Operated for at least 30 minutes. Functioned normally at time of inspection.
- 4.2. EXCEEDED LIFESPAN--CONDENSER: The air conditioner is aged at 25 years. It has exceeded its statistical life expectancy and should be monitored for replacement. Typical lifespan of an air conditioning unit is 10-15 years. The Client is advised to anticipate replacement in the immediate future. The Inspector advises the Client to arrange to have a professional, NATE certified HVAC contractor further evaluate and address as necessary.
- 4.3. OVERFUSED: The 40 Amp breaker for the air conditioning unit is too large as per the manufacturer's rating of 30 Amps. It should be changed as an oversized breaker could cause damage to the unit and could void the warranty. The Inspector advises the Client to arrange to have a professional, licensed electrician change the breaker.

ICP brand condenser--2.5 tons--25 years old

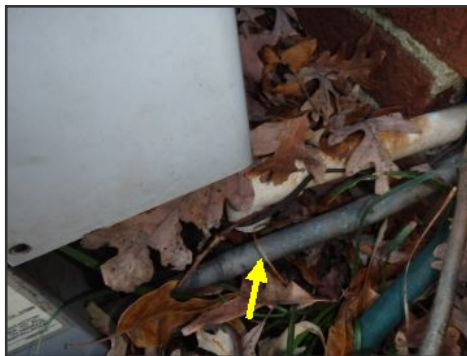
missing insulation

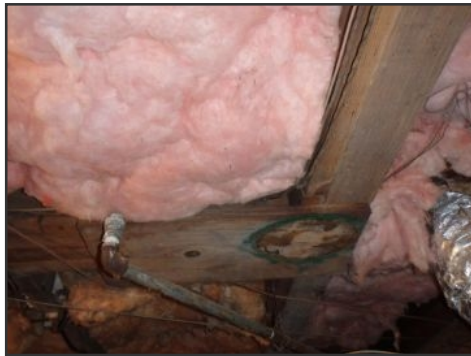
5.4. MISSING POST AT GIRDER/BEAM: The Inspector observed a missing post to provide floor support at a beam/girder near the center of the crawl space (see image). Correction is recommended with installation of 6x6" preservative-treated post or 3" steel post founded on poured in place concrete footer set 12" deep. The Inspector advises the Client to arrange to have a professional contractor further evaluate and address as necessary.

missing support under beam--center of crawl space

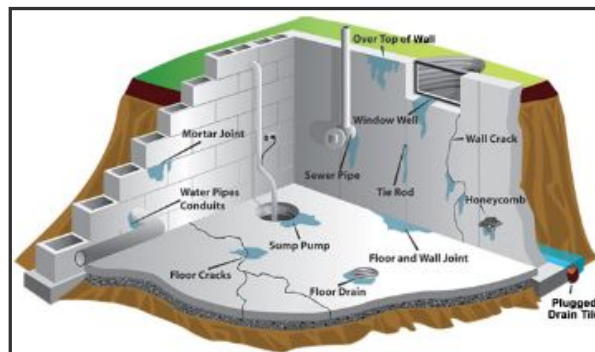
6.2. PRIOR MOISTURE STAINS--CRAWL SPACE: Prior indicators of water entry at the crawl space were observed. Water may have entered during strong storms. No active water was noted at time of inspection, but it should be monitored. If water is discovered, then steps should be taken to mitigate the problem.

how water can enter the cellar

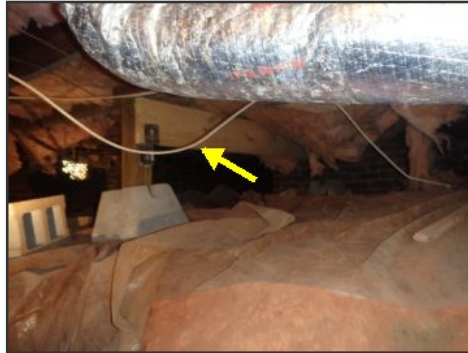
1.2. DEFICIENT SUPPORT UNDER BEAM/HEADER: The Inspector observed a auxiliary beam at side D that needs to be supported with a properly installed posts and footers. See image. This beam is not critical; however, repair is still advised. The posts should be minimum 6x6" preservative-treated and founded on a poured-in-place concrete footer that is 12" deep. The Inspector advises the Client to arrange to have a professional contractor further evaluate and address as necessary.

auxiliary beam--posts shifting

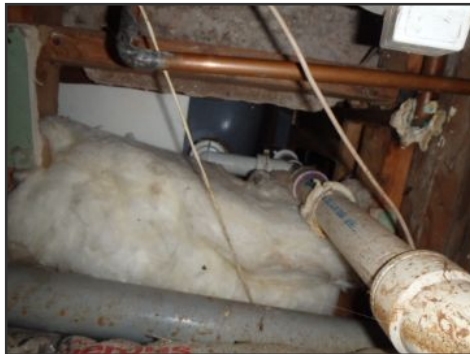
gap under bathroom

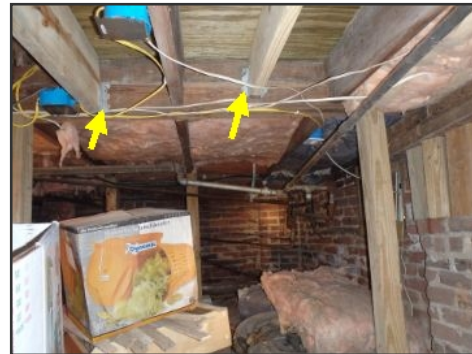
Floor and Wall Structural Systems		
Page 48 Item: 2	Floor System	<p>2.3. JOIST HANGERS--IMPROPER INSTALLATION WITH SCREWS: The Inspector observed some joist hangers at an area under side D of the home. The joist hangers should be installed with 12D nails to prevent joist failure. Screws do not have proper shear ratings; only framing nails should be used. The Inspector advises the Client to arrange to have a professional contractor further evaluate and address as necessary.</p>
Page 49 Item: 6	Wood Destroying Insects	<p>6.1. TERMITE INSPECTION AND BOND: The Client is advised to get a termite inspection for this property prior to closing. This should be obtained from a State of Georgia licensed pest control company. The Inspector advises the Client to obtain a termite protection bond is recommended for this home to protect the home's structure from future termite activity and potential damage. "Repair and Retreat" bonds are best.</p>

2.3. JOIST HANGERS--IMPROPER INSTALLATION WITH SCREWS: The Inspector observed some joist hangers at an area under side D of the home. The joist hangers should be installed with 12D nails to prevent joist failure. Screws do not have proper shear ratings; only framing nails should be used. The Inspector advises the Client to arrange to have a professional contractor further evaluate and address as necessary.

joist hangers improperly installed with screws

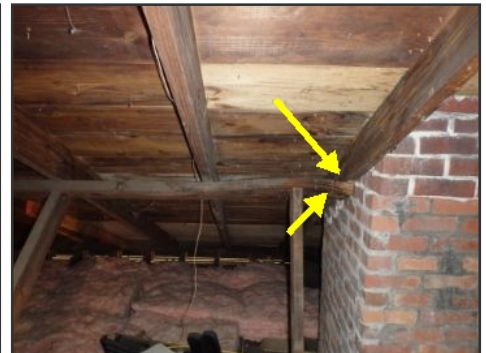
4.5. **PRIOR MOISTURE DAMAGE--ROOF SYSTEM:** The Inspector observe moisture stains at side D of the attic. The rafter and purlin near the chimney are damaged. Repair with sister members. The Inspector advises the Client to arrange to have a professional contractor further evaluate and address as necessary.

damaged purlin and rafter on side D

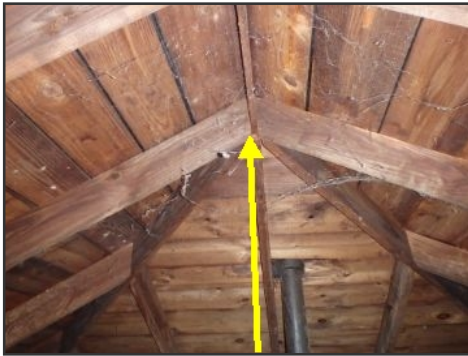
Roof Structure		
Page 50 Item: 4	Roof Framing System Condition	<p>4.3. STRUTS FOR RIDGE RAFTER SUPPORT--MISSING: Struts are needed for the ridge rafter tails. They should be supported with 2-ply 2x6" struts. This concern can be easily addressed. The Inspector advises the Client to arrange to have a professional contractor further evaluate and address as necessary.</p> <p>4.4. COLLAR TIES--NONE INSTALLED: It is recommended to install collar ties. Collar ties should be installed 48" on center between opposing pairs of rafters. The collar ties should be a minimum of 1x4 and nailed at both ends with 3 10D nails. The collar ties should be placed at the upper third of the rafters. The Inspector advises the Client to arrange to have a professional contractor further evaluate and address as necessary.</p> <p>4.5. PRIOR MOISTURE DAMAGE--ROOF SYSTEM: The Inspector observe moisture stains at side D of the attic. The rafter and purlin near the chimney are damaged. Repair with sister members. The Inspector advises the Client to arrange to have a professional contractor further evaluate and address as necessary.</p>

recommend adding strut under ridge rafter tails

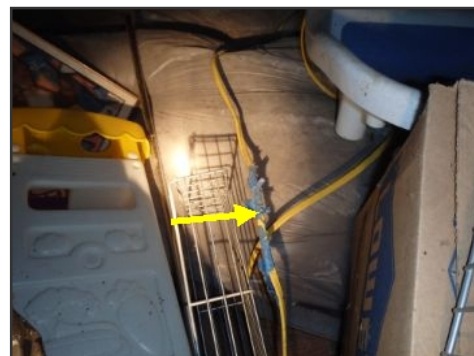
example rodent damage
