# The Inspection Company, LLC

## Property Inspection Report

124 Any Street, Atlanta, GA 30327  
Inspection prepared for: John Q. Client  
Real Estate Agent: George Heery - Heery Brothers

Date of Inspection: 4/16/2013 Time: 9:30 AM  
Age of Home: 51 years Size: 2,679  
Weather: 67-74°, partly cloudy

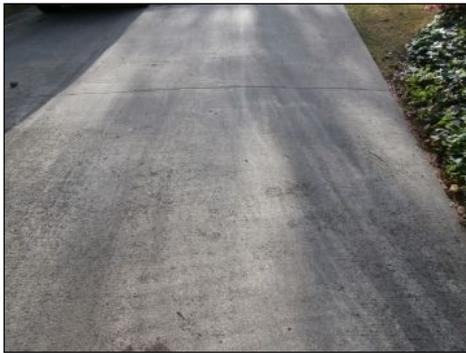
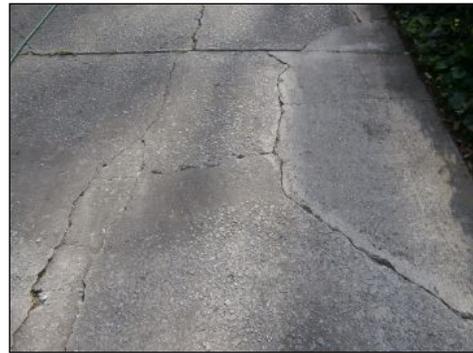
Observations:  
 2.1. **MINOR CRACKING:** The Inspector observed some minor, typical cracking at the driveway. Heaved and uneven areas at cracks could be a trip hazard. Have corrected or use with caution. The cracks are otherwise minor; consider sealing or grouting. The Inspector advises the Client to arrange to have a professional contractor further evaluate and address as necessary.  
 2.2. **SIGNIFICANT CRACKING AND HEAVING AT LOWER SECTION:** The Inspector observed significant cracking at the driveway. Heaved and uneven areas at cracks could be a trip hazard. The Client is advised to have damaged areas replaced to restore to even condition. The Inspector advises the Client to arrange to have a professional contractor further evaluate and address as necessary.

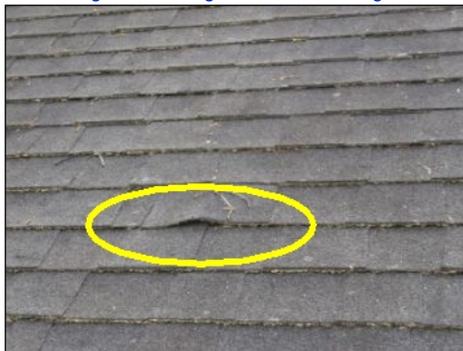
- 1.3. **NAIL POPS:** The Inspector observed some limited areas of "nail pops". This is caused by fasteners that are not set flat the the roof surface. They should be corrected. This is a minor concern that can be easily addressed. The Inspector advises the Client to arrange to have a professional certified roofing contractor further evaluate and address as necessary.

example "nail pops"

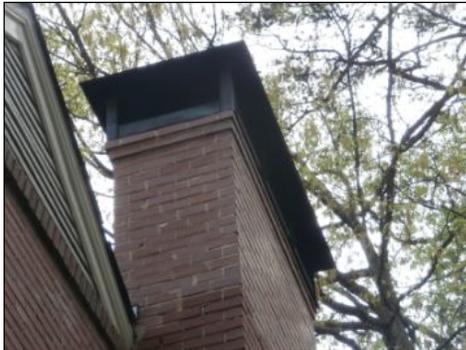
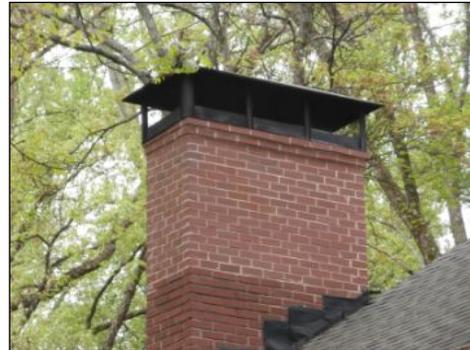
4.2. The top section of the chimney appears to have been replaced. The brick are not the same style. The reason for replacement could not be readily determined.

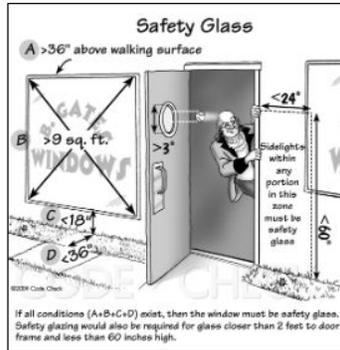
- 5.1. Appears normal at most locations.
- 5.2. Window glazing did not appear to be tempered (safety glass) at the following location(s): master shower door. This is common for older homes. Current building standards require that glass used in doors, used at windows adjacent to exterior doors, used near stairways, and used near bathtubs be tempered however. The glazing should be used with caution unless updated. The Inspector advises the Client to arrange to have a professional contractor further evaluate and address as necessary.

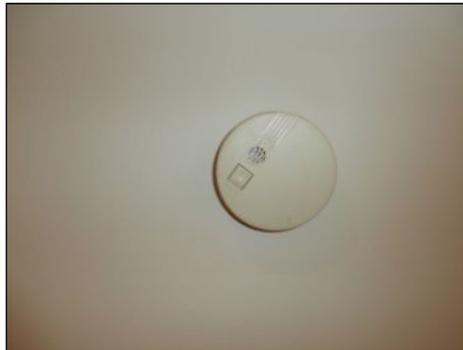
1.1. Appears normal. Detectors were tested with artificial smoke.  
 1.2. SMOKE DETECTORS: It is also highly recommended to add smoke detectors inside each bedroom and downstairs hallway. At least two hardwired and interconnected smoke detectors are highly recommended for every home, one for each level and one for each sleeping room too. It is very important to change smoke detector back-up batteries prior to occupancy and ongoing every six months. Purchase and install new detectors every ten (10) years as recommended by the US Fire Administration. Just like any electrical appliance, the components of smoke alarms wear out over time. When a smoke alarm reaches 10 years of use, the potential of failing to detect a fire increases substantially. Replacing them after 10 years reduces the likelihood of failure. Inoperable detectors can lead to serious injury or death should the home have a fire. The best recommended smoke detector type combines ionization and photoelectric technology into one unit. The smoke detectors should be mounted to within 12" of the ceilings. The Inspector also recommends the Client purchase at least two ABC rated fire extinguishers for the home.

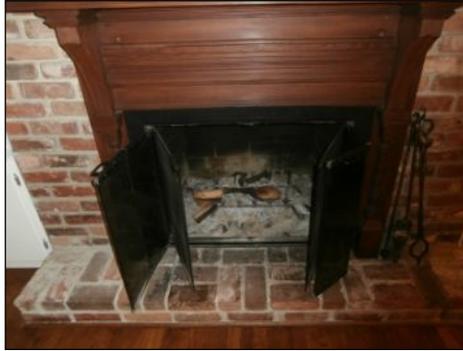
3.1. CRACKS AT FIREBOX: Minor hairline cracks noted at firebox where brick front meets brick liner. it is recommended to grout cracks and continue to monitor. The Inspector advises the Client to arrange to have a professional contractor further evaluate and address as necessary.

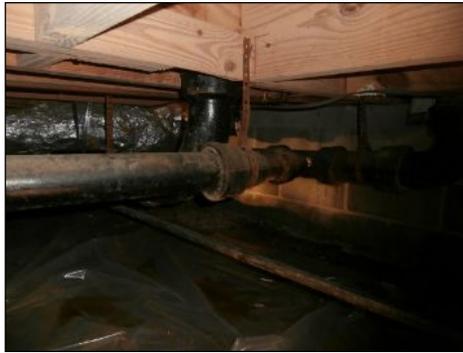
4.2. CAST IRON PIPE: The home still has most of the original cast iron drain/waste/vent pipes in use. While the system still appears to be serviceable, there may be concealed deterioration inside the pipe and underground. The Inspector cannot predict the remaining useful lifespan of the pipes. The pipes should be monitored in the meantime.

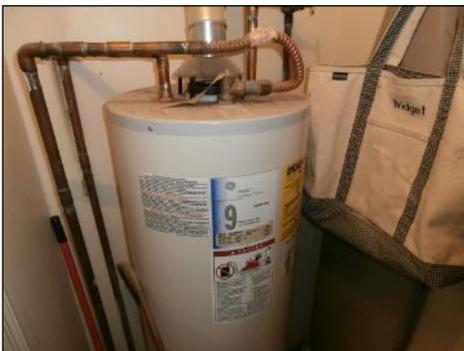
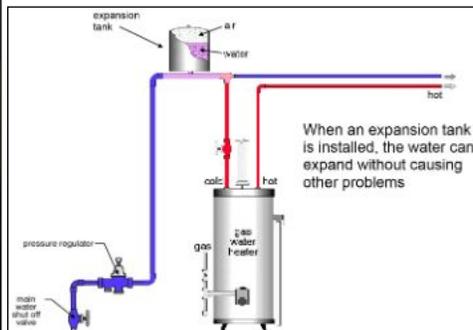
5.5. EXPANSION TANK: The Inspector observed that the gas water heater does not have an expansion tank installed. The Inspector advises the Client to arrange to have a professional plumbing contractor further evaluate and address as necessary.

5.6. LEAK: There appears to be a leak at the drain valve (service valve). The Inspector advises the Client to arrange to have a professional contractor further evaluate and address as necessary.

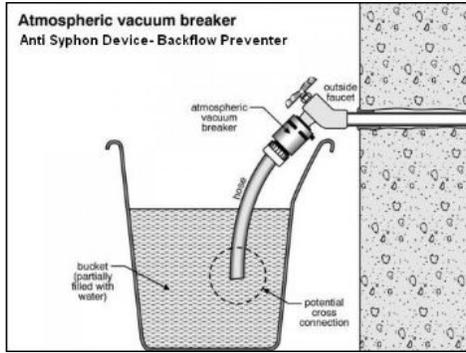
10.1. BACKFLOW PREVENTION: The hose bibs need backflow prevention adaptors (anti-siphon devices). This is an easy correction that can prevent drinking water contamination. Adaptors can be installed by a homeowner; no special skills required.

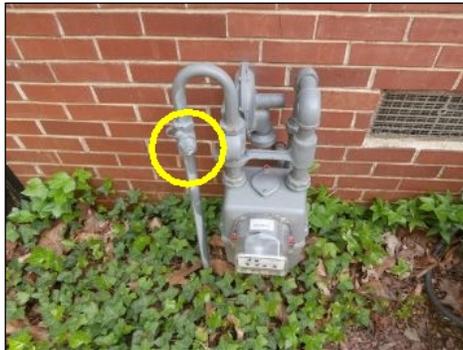
12.1. MAIN GAS VALVE: There is no main gas valve on the homeowner's side of the gas meter. This is common for older homes. The Inspector advises that the Client arrange to have a professional licensed plumbing contractor further evaluate and address as necessary.

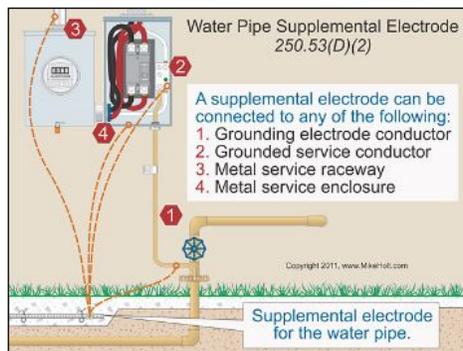
4.1. **NO GROUNDING CONDUCTOR OBSERVED:** A grounding wire was not observed. A primary and supplemental grounding wire system should be installed. The Inspector advises the Client to arrange to have a professional, licensed electrician further evaluate and address as necessary for safety.

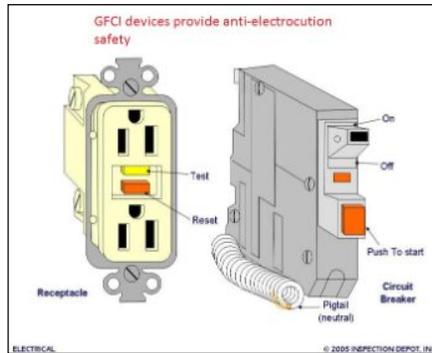
Observations:  
11.1. Appears normal at most locations. GFCI devices should be tested regularly as devices have high failure rate.  
11.2. EXTERIOR GFCI: The front exterior receptacle is not GFCI compliant. GFCI technology is required by the National Electrical Code to protect occupants against electrical shock and injury at "wet locations." GFCI protection may not be present in some older homes, but it is suggested as an upgrade. The Inspector advises the Client to arrange to have a professional, licensed electrician further evaluate and address as necessary for safety. Install WR receptacle with GFCI and weather head.

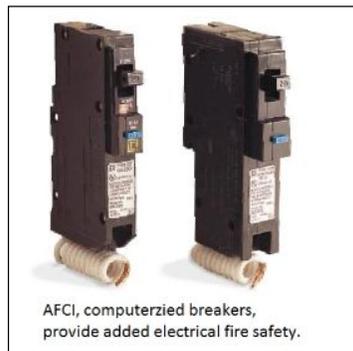
Observations:  
12.1. AFCI TECHNOLOGY: It is advised to consider updating all of the home's 15 and 20 Amp single pole breakers to AFCI type, new technology, for added electrical fire safety. Note that this technology is not a code requirement for older homes, but it is suggested as an upgrade for improved safety.

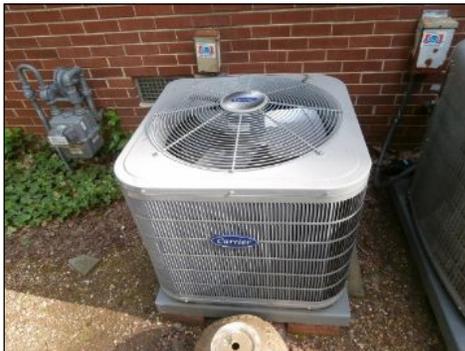
*The air condensing unit is relatively new. Typically, units have a 13-15 year lifespan.*

air condensing unit

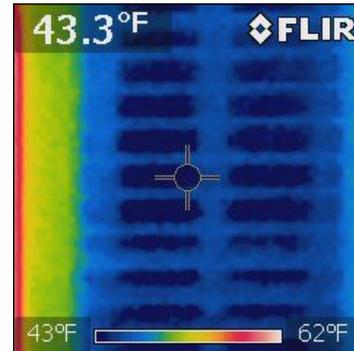
Normal temperature drop

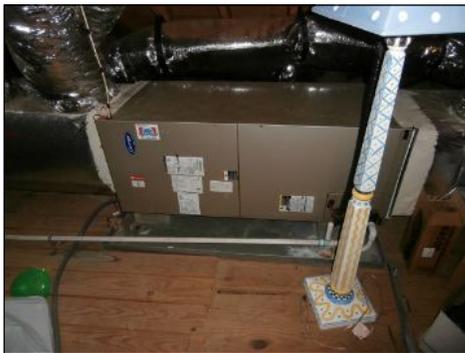
**GOOD NEWS:**  
 The furnace is relatively new. Lifespans are typically 15-17 years for gas furnaces.

general image of heat pump

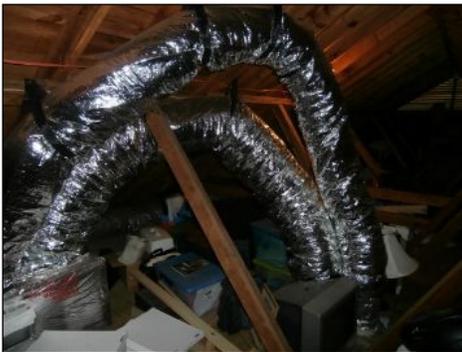
Observations:  
**2.1. CLEANING & SERVICING OF DUCTWORK:** The ductwork is recommended to be cleaned and serviced. Insulating jackets need minor general repairs. The duct joints should be sealed with mastic. Servicing should help prevent wasted energy by reducing loss of conditioned air. The Inspector advises the Client to arrange to have a professional, NATE certified HVAC contractor further evaluate and address as necessary.

example ductwork

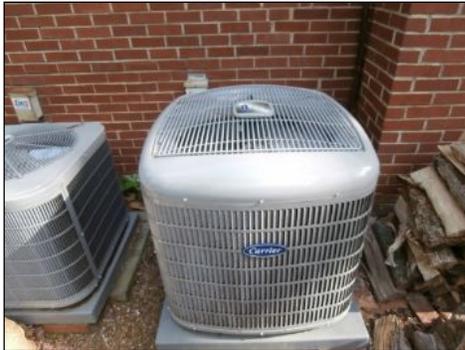
3.1. *Appears normal. The air conditioner was operated for at least 30 minutes. It functioned normally at time of inspection by producing an acceptable temperature drop.*

*air condensing unit*

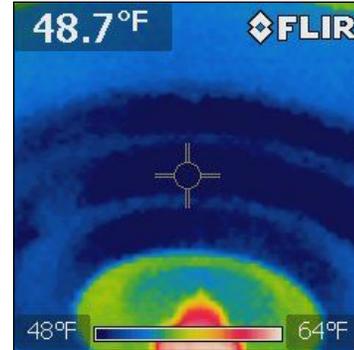
*Normal temperature drop*

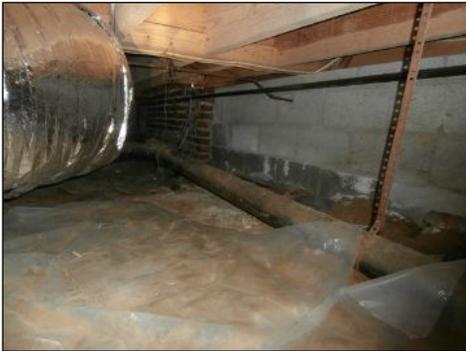
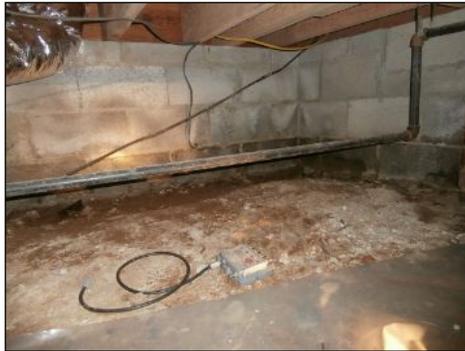
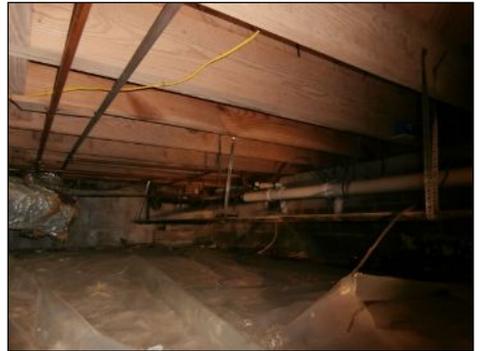
2.1. Appears normal.

underfloor crawl space--general image

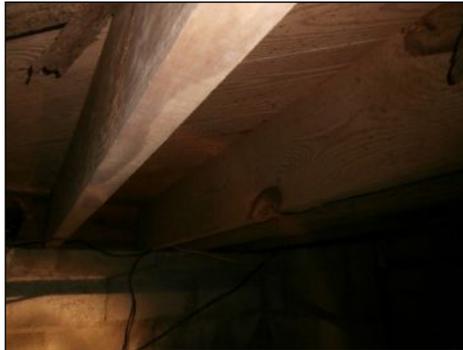
2.1. Appears normal (as readily visible). Minor deflection is noted at kitchen. Consider installing auxiliary support. The Inspector advises the Client to arrange to have a professional contractor further evaluate and address as necessary.

*general image of floor system*

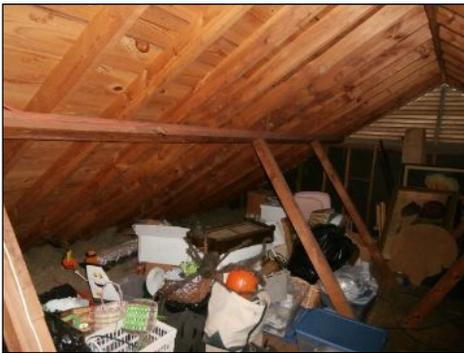
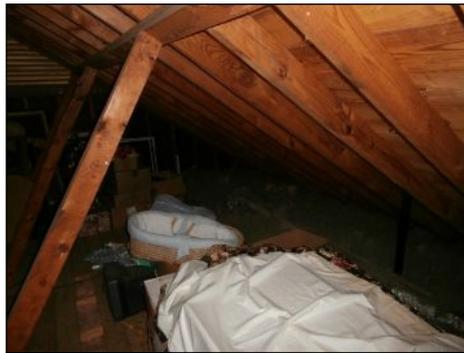
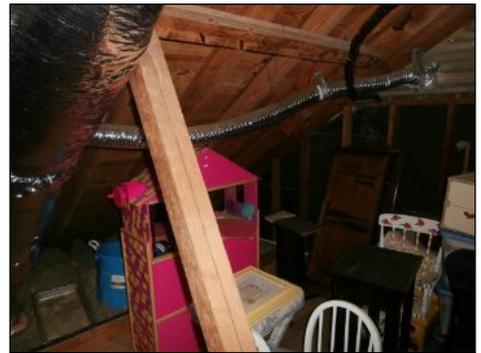
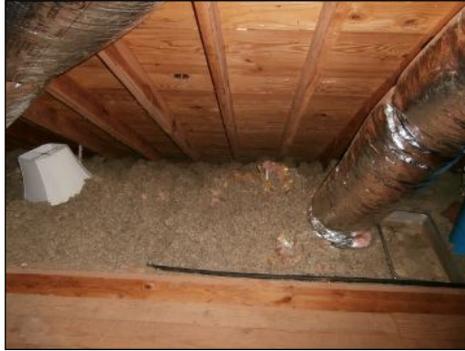
**4.1. STRUTS:** The struts for the purlins that brace the rafters are not evenly spaced. They should be installed every 48". The struts should be 2-ply 2x4's, not single-ply. This concern can be easily addressed. The Inspector advises the Client to arrange to have a professional contractor further evaluate and address as necessary.

**4.2. COLLAR TIES:** The Inspector did not observe collar ties at the rafters; this is common for older homes. Collar ties can improve roof stability. Collar ties should be installed 48" on center between opposing pairs of rafters. The collar ties should be a minimum of 1x4 and nailed at both ends with 3 10D nails. The collar ties should be placed at the upper third of the rafters.

general image of attic
