The Inspection Company, LLC

Property Inspection Report

123 Atlanta Ave., Atlanta, GA 30316
Inspection prepared for: John Q. Client
Real Estate Agent: Jane A. Agent - ABC Realty Company

Date of Inspection: 12/10/2014 Time: 9:00 AM
Age of Home: 1930 | Size: 1400 SF
Weather: 51°, sunny

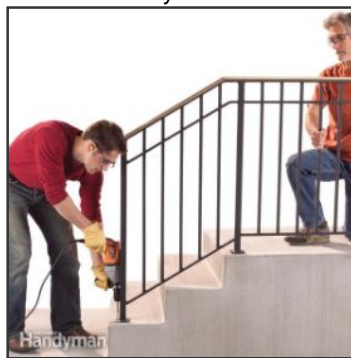
Outdoor Environment		
Page 12 Item: 2	Walkway	<p>2.3. GRIPPABLE HANDRAIL--STEPS AT WALKWAY: The Inspector did not observe a handrail at the exterior steps at side A near the walkway that leads to street or at side D at brick steps to back yard. The brick steps at side D are also uneven and irregular; this increases risk hazard--consider repair there too. Handrails are very important for mitigating falls on steps, a leading cause of home-related injuries. Installation of handrails is always highly recommended where four risers or more are present. The Inspector advises the Client to arrange to have a professional contractor further evaluate and address as necessary.</p>
Page 13 Item: 3	Deck	<p>3.2. BOLTING OF LEDGER--DECK IMPROPERLY ATTACHED THROUGH BRICK CLADDING: The Inspector observed that the deck improperly attaches to the side of the home with bolts going through the brick cladding. The brick serves as a cladding and is not structural. It should not be used to support the deck's load. Correction is recommended with installation of 6x6" preservative-treated posts founded on top of poured-in-place concrete footers set 18" deep. The posts should be installed every 6-8' or under joints of the ledger. The Inspector advises the Client to arrange to have a professional contractor further evaluate and address as necessary. (One & Two Family Dwelling Code on lintels states that "masonry veneer shall not support any vertical loads other than the dead load of the veneer above." Also see page 11: http://www.dca.state.ga.us/development/constructioncodes/programs/documents/2012IRC-DeckManual2014Amendments_001.pdf</p> <p>3.3. BOLTING OF FLOOR BAND TO POSTS: The Inspector observed that the deck floor structure is not bolted to the sides of the posts. This is very important. Two 1/2" through-bolts should be added to every support post to prevent deck detachment. The Inspector advises the Client to arrange to have a professional contractor further evaluate and address as necessary.</p> <p>3.4. BOLTING OF BEAM TO POSTS: The Inspector observed that the beam is not bolted to the side of the support posts. This is very important. Two 1/2" through-bolts should be added at every post to prevent deck detachment. The Inspector advises the Client to arrange to have a professional contractor further evaluate and address as necessary.</p> <p>3.5. HORIZONTAL SUPPORT--DEFICIENT: The Inspector observed deficient horizontal support at the deck. The deck moves (see video). Diagonal braces should be added at the posts to provide sufficient support to prevent movement. This is an important but easily correctable concern. The Inspector advises the Client to arrange to have a professional contractor further evaluate and address as necessary.</p> <p>3.6. JOIST HANGERS--IMPROPER INSTALLATION WITH SCREWS: The Inspector observed some joist hangers at deck on the right side section. The joist hangers should be installed with 12D nails to prevent joist failure. Screws do not have proper shear ratings; only framing nails rated for use with preservative-treated wood should be used. Additionally, the hangers are undersized. The Inspector advises the Client to arrange to have a professional contractor further evaluate and address as necessary.</p>

steps at walkways

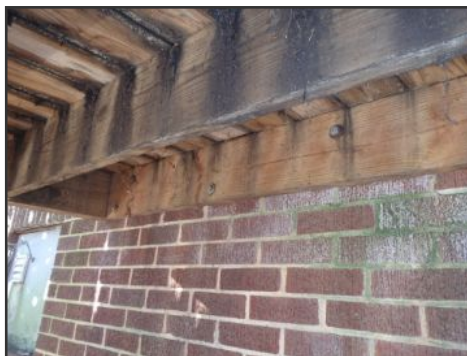
decks should not be bolted through brick

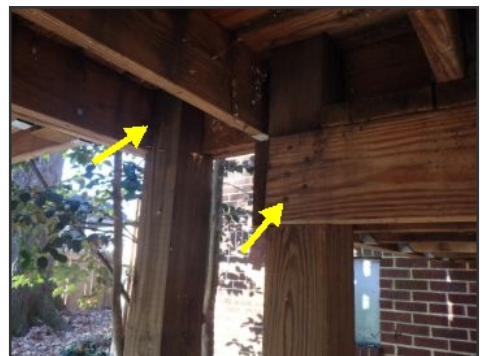
beams not bolted to support posts--example

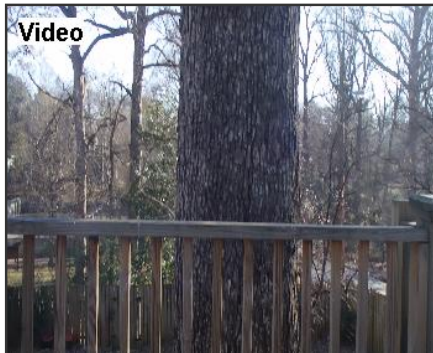
3.5. HORIZONTAL SUPPORT--DEFICIENT: The Inspector observed deficient horizontal support at the deck. The deck moves (see video). Diagonal braces should be added at the posts to provide sufficient support to prevent movement. This is an important but easily correctable concern. The Inspector advises the Client to arrange to have a professional contractor further evaluate and address as necessary.

Video

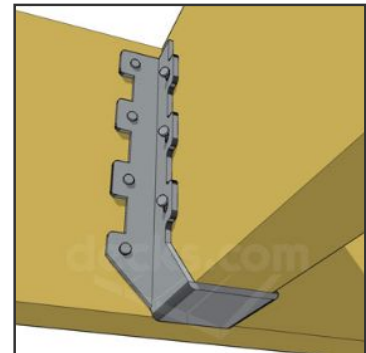
3.6. JOIST HANGERS--IMPROPER INSTALLATION WITH SCREWS: The Inspector observed some joist hangers at deck on the right side section. The joist hangers should be installed with 12D nails to prevent joist failure. Screws do not have proper shear ratings; only framing nails rated for use with preservatively-treated wood should be used. Additionally, the hangers are undersized. The Inspector advises the Client to arrange to have a professional contractor further evaluate and address as necessary.

proper joist hanger installation

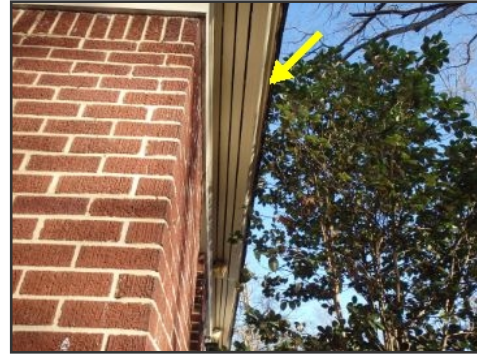
tree limbs need maintenance

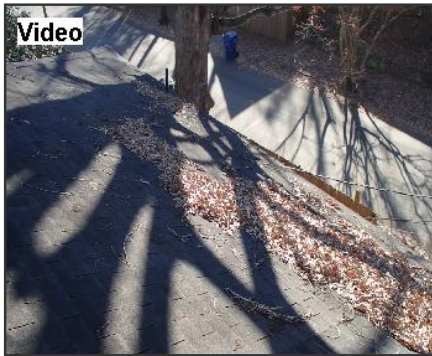
1.1. **NEAR END OF LIFESPAN--ROOF COVERING MATERIAL:** The roof covering is aged and is near the end of its lifespan. The Client is advised that replacement will be needed in near future (2-3 years). Note that there are 2-3 layers of material. Make repairs in meantime. The Inspector advises the Client to arrange to have a professional roofing contractor further evaluate and address as necessary.

click to play for pan view of roof

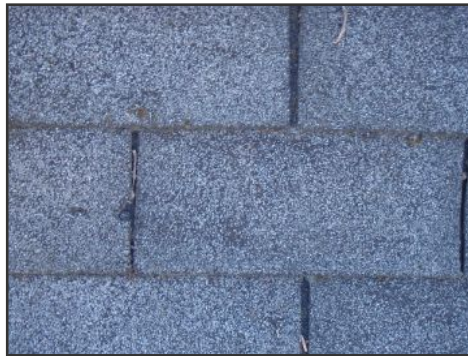
1.2. **GENERAL MINOR DAMAGE AT ROOF COVERING:** The Inspector observed some areas of asphalt shingles with tears, abrasions, nail holes, etc. The damaged shingles should be repaired to prevent possible roof leaks. The Inspector advises the Client to arrange to have a professional roofing contractor further evaluate and address as necessary.

close up of roofing material

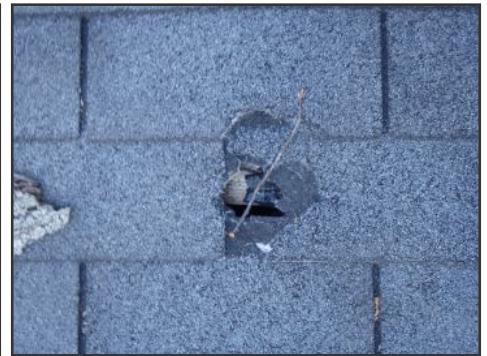
hole at porch

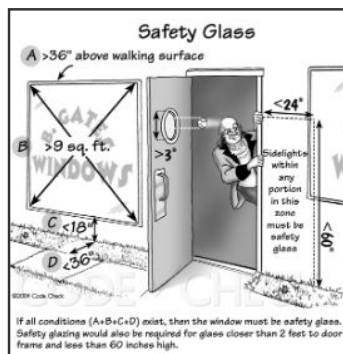
- 5.1. Appears normal.
- 5.2. TEMPERED GLASS (SAFETY GLASS)--OLDER HOME--FRENCH DOORS: The Inspector observed that glass panes at the French interior doors are not tempered. This is common for older homes. Current building standards require that glass used in doors be tempered for safety. The doors should be used with caution unless updated. The Inspector advises the Client to arrange to have a professional contractor further evaluate and address as necessary.

safety glass

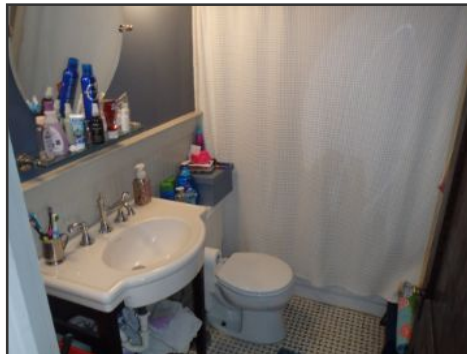
- 2.1. Appears normal. Normal tub drain when tested for several minutes.
- 2.2. Appears normal. Water controls were tested.
- 2.3. GOOD NEWS:
The shower head is low flow which should save water.
- 2.4. Ceramic chips noted at bathtub.

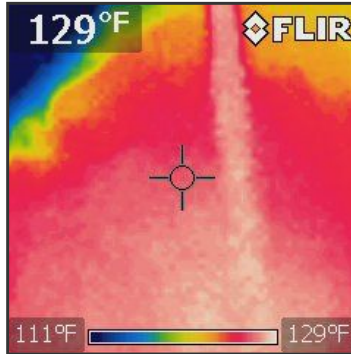
6.1. **HOT WATER TEMPERATURE TOO HIGH:** The hot water temperature was measured at 129° at the time of inspection. The temperature should be maintained at 120° or less for safety and reduced wear and tear on the pipes.

hot water temp

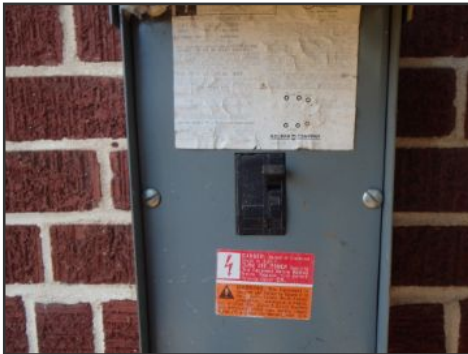
main disconnect B

Location of main disconnect: *Exterior at exterior panel.*
 Observations:
 3.1. Appears normal. Two disconnects noted. One for each meter.

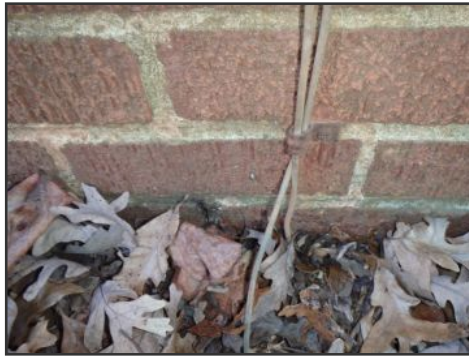
grounding connections

Observations:
 4.1. Appears normal.

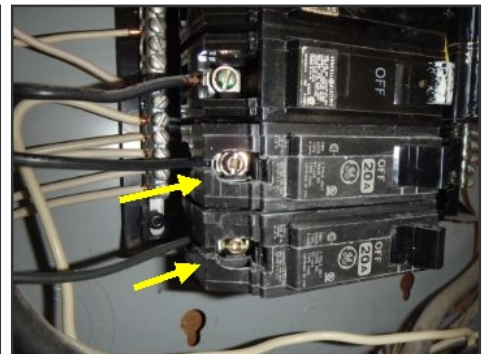
5.2. OVERFUSED CIRCUITS--BEDROOM PANELBOARD: The Inspector observed two 14 gauge rated circuits that were improperly connected to 20 Amp breakers. They should be connected to 15 Amp breakers. The Inspector advises the Client to arrange to have a professional, licensed electrician further evaluate and address as necessary for safety.

breakers too large for 14 gauge circuits

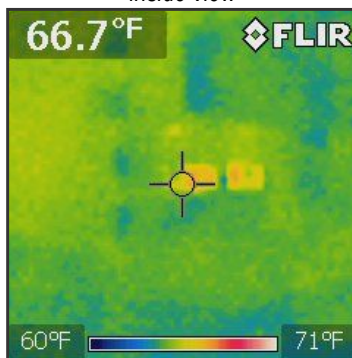
normal infrared image of panelboard

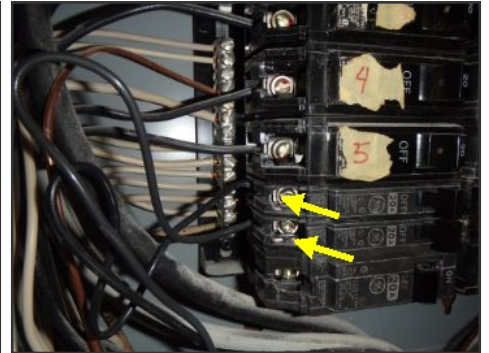
6.2. OVERFUSED CIRCUITS--KITCHEN PANELBOARD: The Inspector observed two 14 gauge rated circuits that were improperly connected to 20 Amp breakers. They should be connected to 15 Amp breakers. The Inspector advises the Client to arrange to have a professional, licensed electrician further evaluate and address as necessary for safety.

breakers too large for 14 gauge circuits

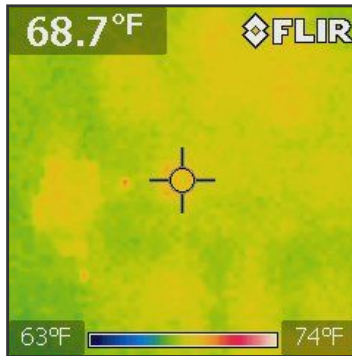
normal infrared image of panelboard

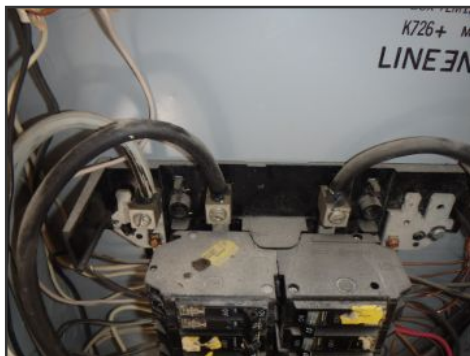
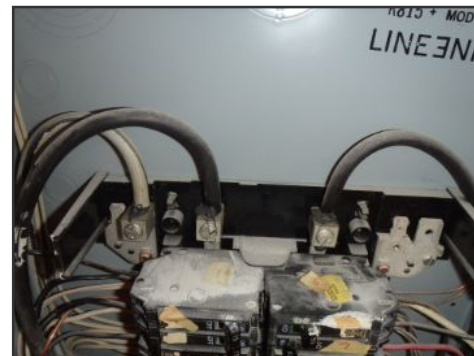
7.1. *Appears normal.*

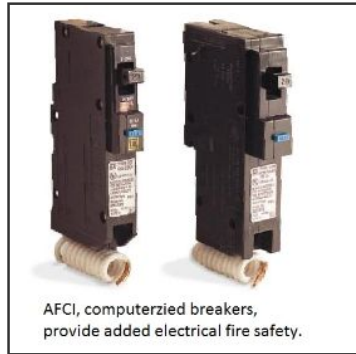
AFCI breakers

- 13.1. AFCI TECHNOLOGY: AFCI breakers, computerized breakers, are more effective than standard breakers at preventing electrical fires. It is advised to consider updating all of the home's 15 and 20 Amp single pole breakers to AFCI type, new technology, for added electrical fire safety. Note that this technology is not a code requirement for older homes, but it is suggested as an upgrade for improved safety.

AFCI, computerized breakers,
provide added electrical fire safety.

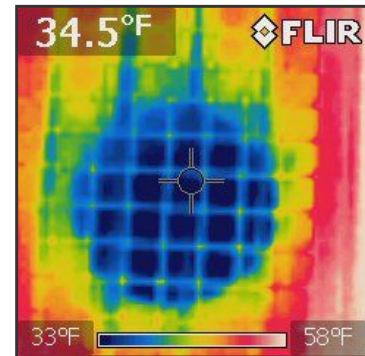
normal temperature drop

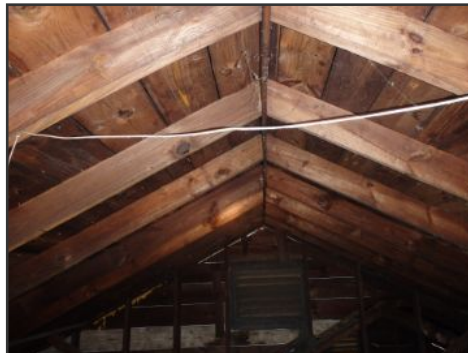
no collar ties are installed

4.4. **COLLAR TIES--NONE INSTALLED:** It is recommended to install collar ties. Collar ties should be installed 48" on center between opposing pairs of rafters. The collar ties should be a minimum of 1x4 and nailed at both ends with 3 10D nails. The collar ties should be placed at the upper third of the rafters. The Inspector advises the Client to arrange to have a professional contractor further evaluate and address as necessary.

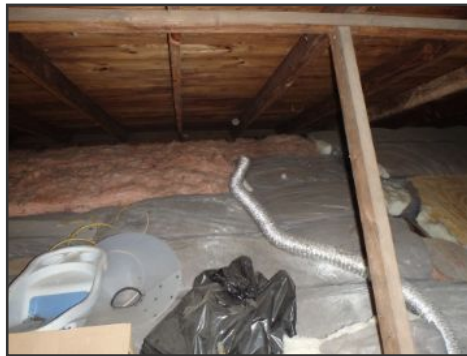
5.1. DUCT NOT EXTENDED TO EXTERIOR--BATHROOM POWER FAN: The Inspector did not observe a duct for the bathroom power exhaust that terminates to the exterior; the fan terminates inside the attic. A duct should be installed to vent the damp air to the exterior. The Inspector advises the Client to arrange to have a professional contractor further evaluate and address as necessary.

vent does not terminate to exterior
